Eaton® Clutches

# Failure Analysis Guide

**CLTS1271**

**September 2011**

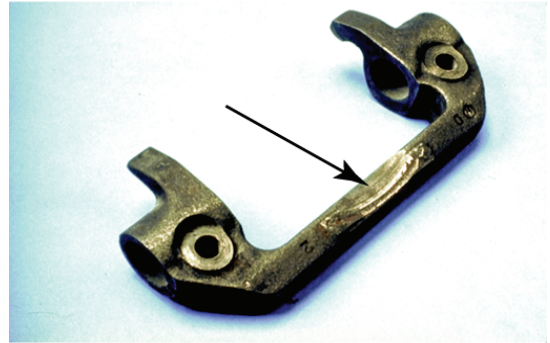
Fig 1

The arrows in Figures 1 and 2 show the areas of contact between the release yoke bridge and the clutch cover. Overstroking of the yoke, in an attempt to obtain the required 1/2" - 1" clutch brake squeeze, is a typical cause of this failure.

- Worn clutch brake
- Broken or missing clutch brake
- Worn or incorrect transmission bearing retainer cap (refer to Figure 3)
- Excessive wear on release bearing wearing pads and/or the fingers of the yoke (refer to Figure 1)
- Improper set up of the linkage system. Consult your OEM service manual
- Incorrect yoke installed

**Note:** The clutch cover can be reused if the above items are corrected, a new yoke is installed, and there are no broken or cracked parts on the cover. The above failure is typically preceded by a noise complaint and/or vibrating clutch pedal at the point where the clutch pedal is fully depressed. Depending upon the amount of wear (at the bearing cap and/or yoke fingers/wear pads), it may be possible to adjust the linkage to eliminate the noise complaint.

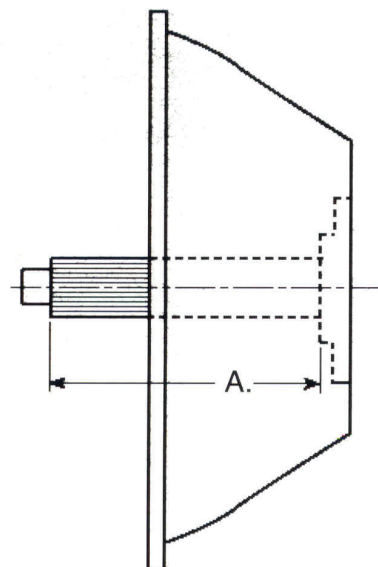
Figure 3

Dimension A, based on SAE standards, is 8.657" (219.9 mm) nominal, and should not be greater than 8.71" (221.5 mm) Ref. 1990 S.A.E. handbook 4:36.106

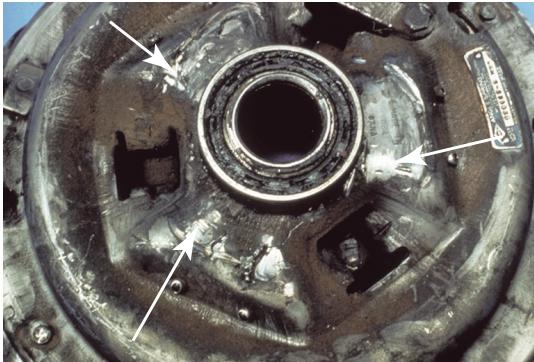
Fig 4

Figures 4 - 5 show the damage that results when the release yoke contacts the clutch cover. More specifically, the fingers have become pinched between the clutch cover and release bearing, resulting in one or more of the following:

- A broken /cracked release bearing housing (not shown)
- Damage to the clutch cover (see arrows, Figure 4)
- Wear to the backside of the yoke fingers (see arrows in Figure 5, top yoke)
- Broken yoke finger(s) (see arrow in Figure 5 bottom yoke)

- Linkage system broke, allowing the loose yoke to contact cover
- Linkage system was improperly reinstalled (example: forgetting to reinstall the cotter key, allowing the clevis pin to come out)
- Adjusting the clutch with the linkage instead of internally using the adjusting ring
- Rotating the ring the wrong direction (counterclockwise instead of clockwise) when adjusting for clutch wear

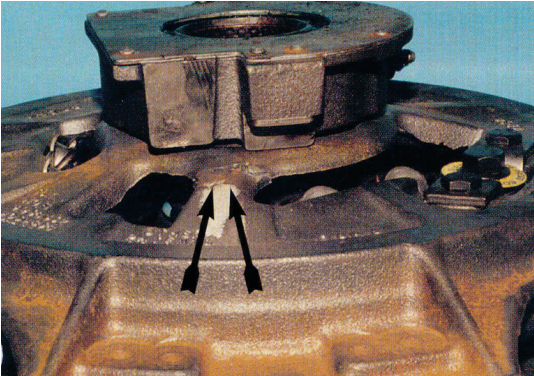
Fig 6

Referring to the arrow in Figure 6, this brand new clutch (Easy-Pedal 1402 S.D.) was damaged during transmission installation. More specifically, the release yoke "fingers" were elevated to the "straight out position" and were allowed to jam into the clutch cover. Subsequent damage might be a broken finger(s)(Figure 5) or bent release yoke / cross shafts. As a result, it is important that these parts be inspected for damage (and replaced if damaged) before installing a new clutch.

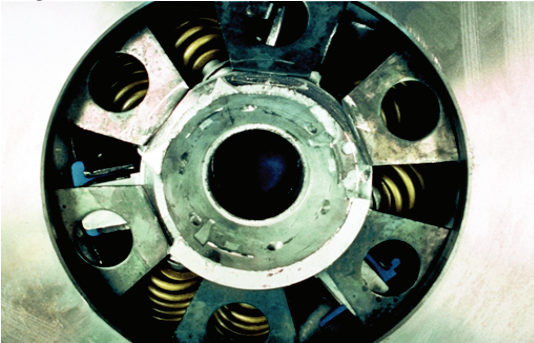
Fig 7

Figure 7 shows what can happen when the levers break through the retainer's nose. The primary cause of this failure is allowing the transmission to hang unsupported in the driven disc during transmission installation.

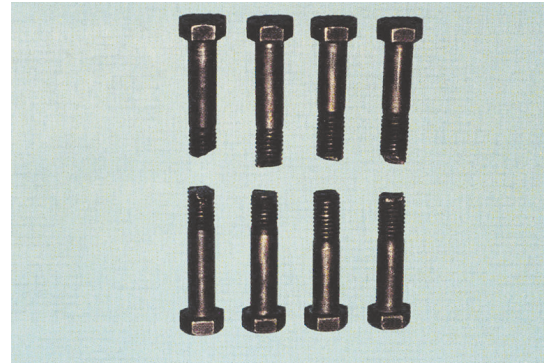
Fig 8

The broken mounting bolts, show in Figure 8, are the direct result of insufficient torquing of these (8) bolts to the flywheel. More specifically, these bolts were loose enough to allow the clutch cover to hammer back and forth against each bolt until they broke. Also, the (8) mounting bolt holes in the clutch cover were “egg-shaped” as a result of the constant hammering.

Another potential cause of the above failure would be the over-torquing of the mounting bolts. Doing so can cause the bolts to fracture and eventually separate from the flywheel. Combining this scenario with low grade mounting bolts will increase the chances of failure.

**Note:** Refer to the Eaton Installation Instructions (packaged with each clutch) to determine the proper mounting bolt torque, minimum grade of bolt, etc., for the specific Eaton Fuller Clutch model you are installing.

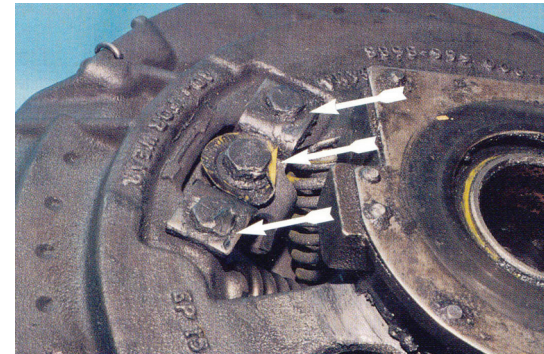
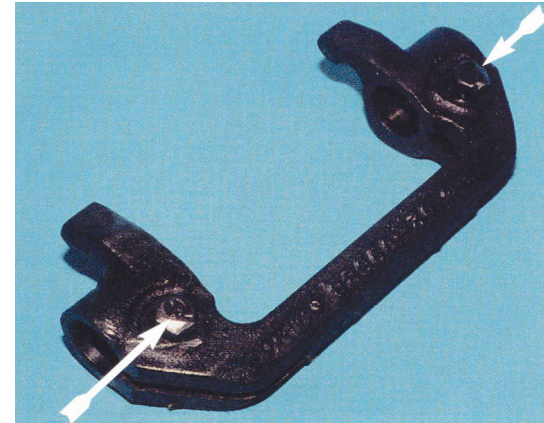
Additional damage occurred to both the clutch cover and the release yoke as a result of their interference with each other (refer to the arrows in Figures 9 and 10). It is worth noting that this service clutch had accumulated 50,000+ miles before it failed.

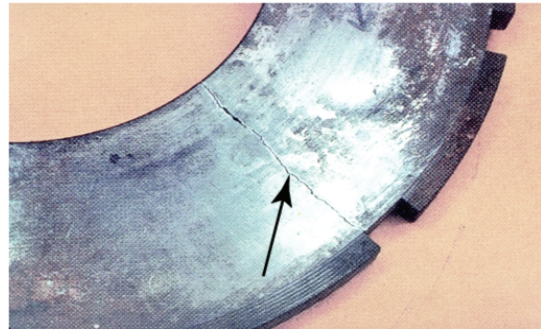
Fig 14

Figure 14 shows a broken intermediate plate. As in the previous example, the heat flow was so intense that the metal could not disperse the heat quickly enough.

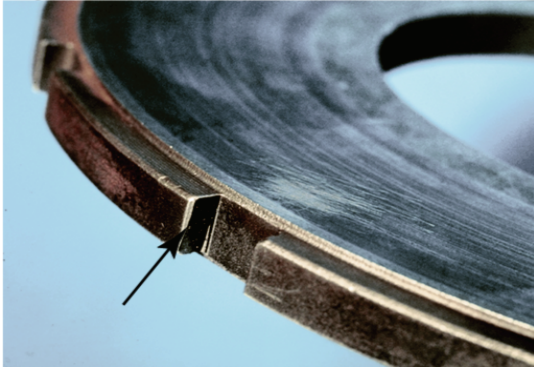
Fig 18

The groove worn in the face of the drive pin slots are on the upper section of the face on one side of the slot (see arrow in Figure 18) and on the lower section on the opposite side of the slot. This indicates that the drive pins were cocked and causing the intermediate plate to hang-up. This will cause release problems and therefore hard shifting. Do not file the slots of the intermediate plate to correct the problem. Instead, you must reset the drive pin(s) until they are square to the flywheel.

**Note:** Always install new Eaton drive pins when installing a new Eaton Fuller 14" Heavy Duty Clutch. This is important because worn drive pins (against the new intermediate plate slots) can prevent the clutch from releasing cleanly. Also, ensure that the drive pins are set squarely to the flywheel's friction surface (refer to the Eaton Installation Instructions packaged with each Eaton Fuller Clutch). Failure to set each drive pin squarely is the most prevalent reason for a "poor release complaint" on a recently installed clutch (Angle Spring and Easy-Pedal Plus 1402).

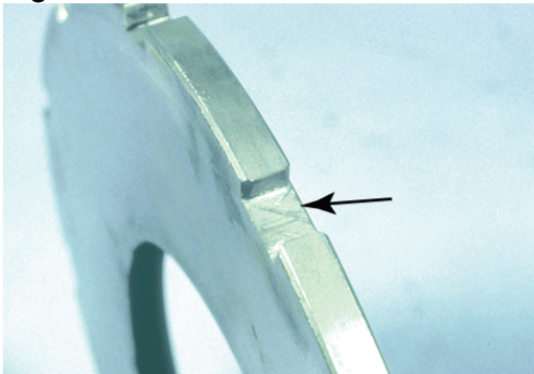
Fig 19

As indicated by the shiny areas on the drive slots, (see arrow Figure 19) the slots of this intermediate plate were hand filed. Eaton does not recommend this practice since it can cause unequal loading on the drive pins in the flywheel. Instead, Eaton recommends that the drive pins be checked for squareness to the flywheel friction surface and reset if necessary (see Eaton Installation Instructions).

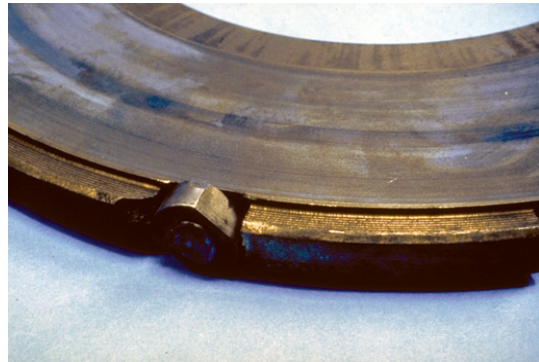
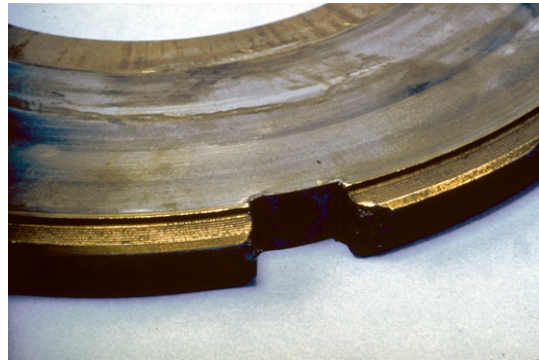
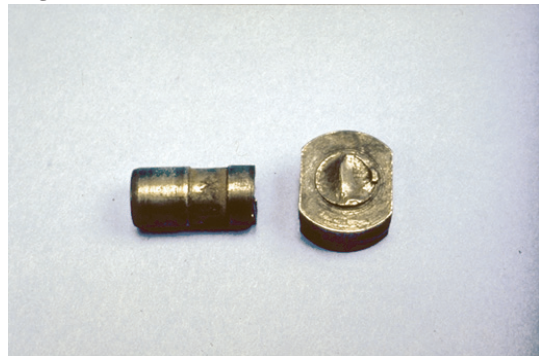
Figure 20 shows a broken drive pin head that has become wedged into the intermediate plate's drive slot. Figure 21 is the same intermediate plate but with excessively worn and broken drive slots. Figure 22 shows a broken drive pin. The above failures can be caused by one or more of the following:

- Failure to use the anti-rattle springs packaged with each super-duty clutch
- Misapplication of the clutch
- Unequal loading on the drive pins as a result of filing the drive slots.

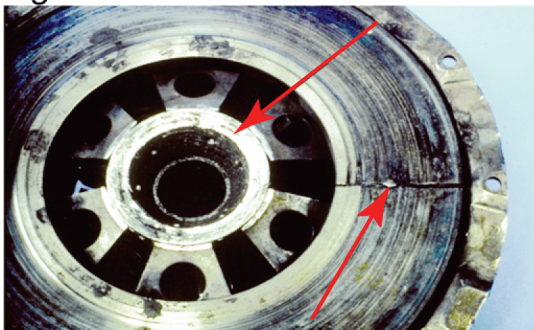
Fig 25

Figure 25 shows the damage done to the nose of the retainer assembly (see arrow) due to contact with the disc rivets. Figure 57 shows the resulting damage done to the rear disc. Adjusting the clutch externally (with the linkage) instead of internally (rotation of adjusting ring) will cause the retainer sleeve/release bearing assembly to move too far forward as the clutch wears, leading to this failure.

An additional result from the above failure is that while the clutch is engaged, it can begin to slip due to the unloading condition created by the disc and retainer interference. This, in turn, will create excessive heat and can cause the pressure plate to break (see Figure 25, black arrow on pressure plate) and/or the ceramic buttons to separate from the disc (see Figure 58). The above failure may also be preceded by a noise complaint.

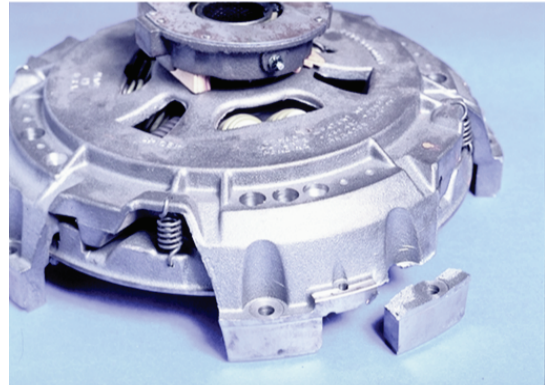
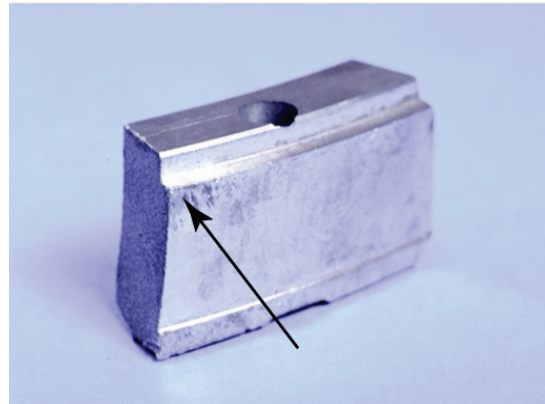
The photo in Figure 27 is a close-up of the broken leg shown in Figure 26. The arrow in this close-up shows where the leg contacted the concrete floor after the clutch was dropped.

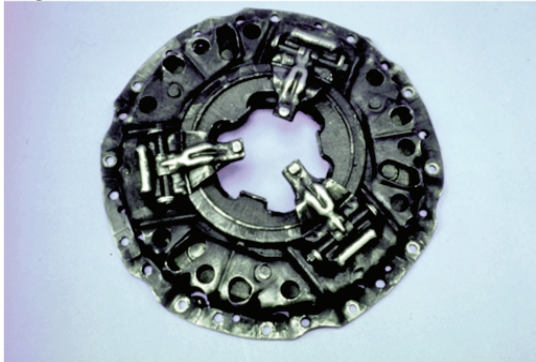
Fig 30

A leaking transmission or a leaky rear main engine seal can coat the clutch cover with oil, as indicated in Figure 30. Figure 41 shows the disc which was run with this cover.

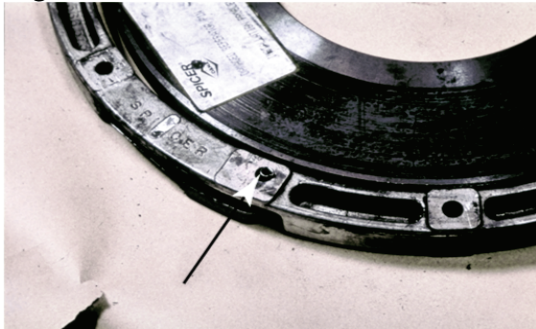
Fig 31

The separator pin shown in Figure 31 became damaged (bent) when it was dropped during clutch installation. To prevent this from occurring, Eaton recommends the use of two (2) guide studs when mounting the intermediate plate and clutch cover to the flywheel (refer to the Eaton Installation Instructions).

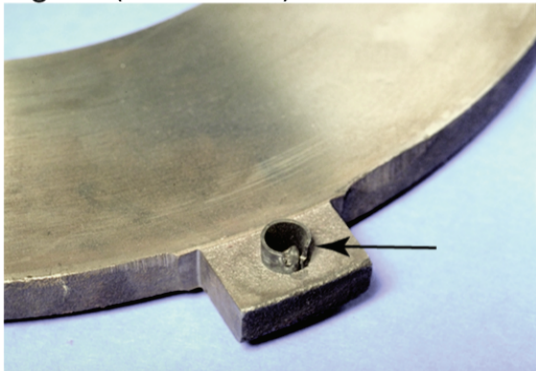
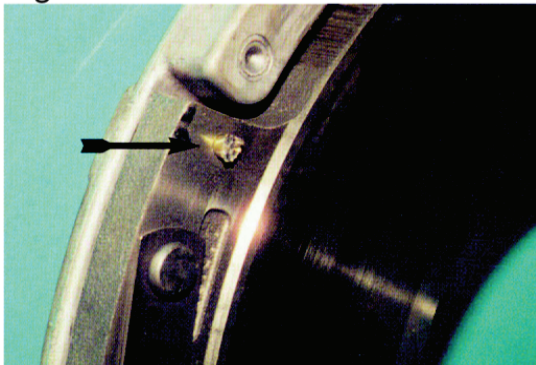
The damage done to the separator pins in Figures 32 and 33 (see arrows) is the result of using the wrong tool combined with excessive force. All four pins (on each intermediate plate) were damaged. When "setting" the four (4) roll pins, the proper tool would be a 1/4" flat nose punch used in conjunction with a small hammer (to help ensure light taps).

A damaged pin(s) can prevent the intermediate plate from retracting evenly when the clutch is disengaged, leading to a "poor release" complaint from the driver. The same complaint can also occur if the mechanic forgets to "set" the four (4) positive separator pins upon installation of the clutch. In you forgot to set the separator pins before installing the transmission, you can still set them through the inspection opening of the transmission.

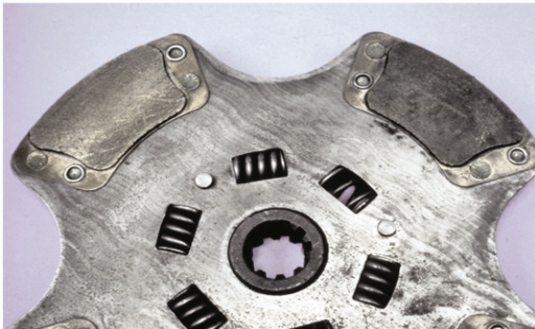
Fig 43

Figure 43 shows a disc with grease on its buttons, flywheel side. When this disc was removed from the truck, all four buttons had a heavy layer of grease on them. The left button has been cleaned to show the contrast with the grease-covered button on the right. Failing to remove the grease (rust preventative) from the flywheel (new or resurfaced) can cause this problem.

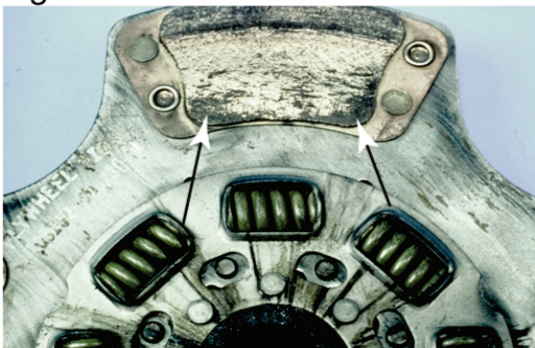
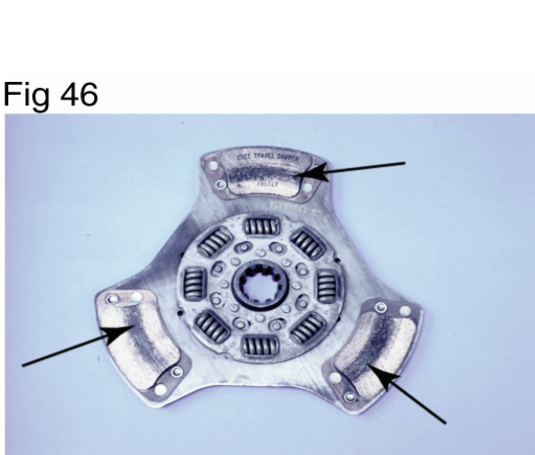
Greasing the splined areas of either the input shaft or disc hub(s) is not recommended because the grease can be spun onto the facing material of the driven disc(s) (refer to both arrows in Figure 44). The circled area in Figure 45 reveals the numerous paths which the grease took as it moved toward the buttons (facing material) of this ceramic driven disc. The photographs in Figures 44-45 are of the same driven disc.

**Note:** Eaton does not recommend the reinstallation of driven discs which have become contaminated with grease or oil.

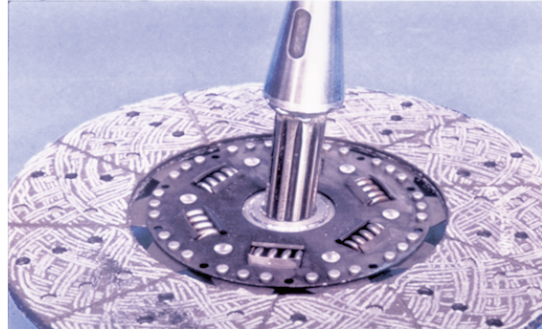
Fig 47

Shown in Figure 47 is a brand new driven disc which was warped during transmission installation (as indicated by the dummy input shaft which is not perpendicular to the disc's hub). More specifically, the transmission was allowed to hang unsupported in the driven disc hub. A driven disc which has become bent due to improper installation techniques should not be reused because of the potential for a "poor release" complaint.

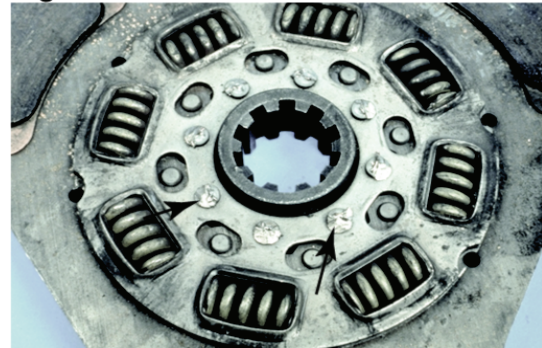
Fig 48

- The rivets of the disc (Figure 48) have been contacting the flywheel's mounting bolts. Some potential causes of this particular interference are as follows:
  - a. Loose flywheel mounting bolt(s) due to inadequate torquing.
  - b. Forgetting to tighten one or more of the mounting bolts when reinstalling the flywheel.
  - c. Installing an extra washer under the flywheel mounting bolt.
  - d. A flywheel which has been resurfaced too many times.
- The damper springs (see arrows, Figure 49 and 50) have been contacting the flywheel mounting bolts because the front driven disc was installed backwards. The driven disc (in Figure 49) had been wearing for a period of time before the interference occurred (as indicated by the full wear pattern on the ceramic buttons) while the one in Figure 50 was run for a very short period.

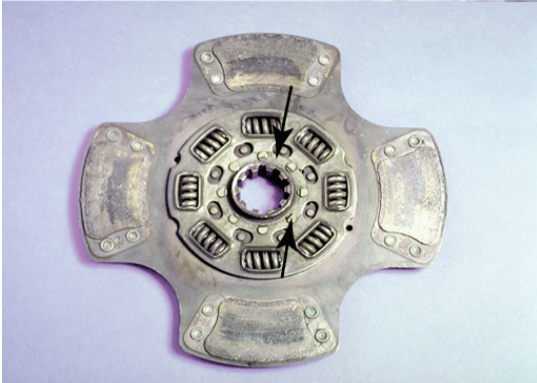
Fig 51

- A disintegrating pilot bearing which is interfering with both the hub and rivets of the driven disc (Figure 51).

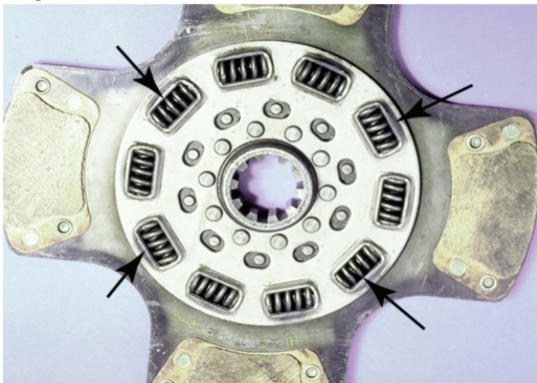
Fig 52

- Installation of the wrong clutch. Figure 52 (see arrows) shows the points of interference that resulted when a 10-spring driven disc was installed where an 8-spring was previously being run. In other words, the recessed area of the flywheel (mounting bolt cavity) was too small for the 10-spring driven disc. Before you mount the new clutch, consult the Eaton Installation Instructions (packaged with each Eaton Fuller Clutch) concerning "potential damper interference". A driver complaint, resulting from the above failure, can be:
  - a. The clutch does not release
  - b. The clutch is noisy during operation

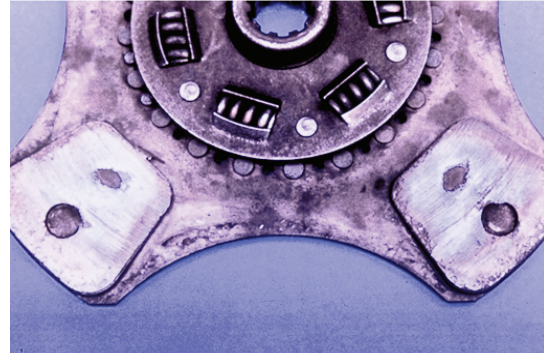
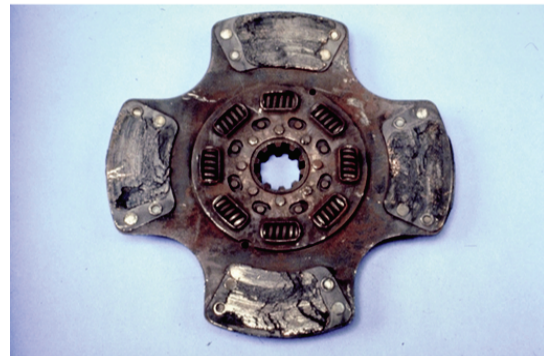
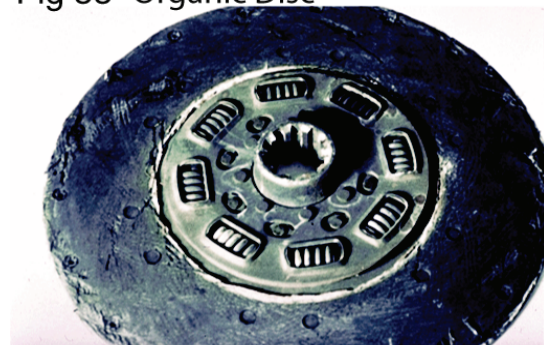
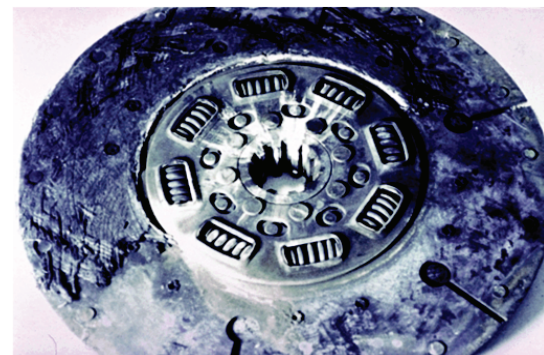
- Lack of free pedal
- Constantly riding the clutch pedal
- Utilizing a slipping clutch as a brake on an incline
- Partial unloading of a clutch due to a binding linkage system, interference, etc.
- Installation and use of improper clutch (wrong application)
- Worn driven disc facings

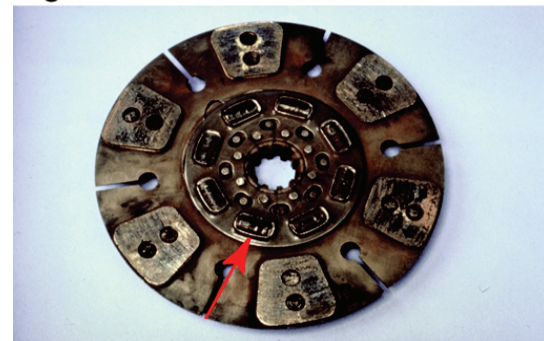
Fig 63

Figure 63 is the disc of a non-Eaton rebuilt clutch. It is an old disc that was rebuilt, as indicated by the presence of dampener springs encased in rubber (see arrow). Consequently, the rubber covered springs can make the disc act as a rigid disc, thus increasing wear to the input shaft and the disc itself. As shown by an arrow in Figure 64, parts of this disc have broken. Also, the springs are wrapped in rubber to prevent any worn ones from falling out after the disc is put into service. Contrast this with the Eaton Fuller Reman Clutches in which only new discs are used.

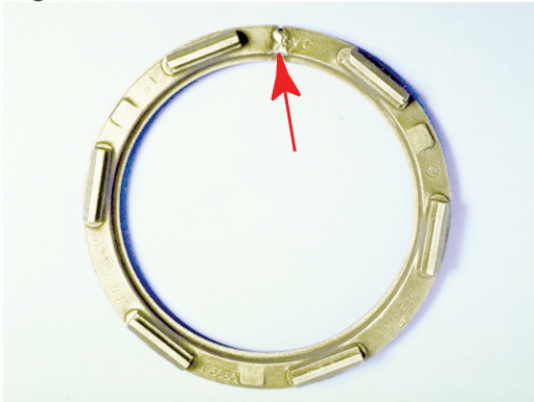
Fig 65

Note also the adjusting ring pictured in Figure 65. It was removed from a non-Eaton rebuilt clutch. This ring was cut open on one side, spread apart, and then welded (see arrow) at a larger diameter to prevent the adjusting ring from becoming loose once it was reinstalled. (Eaton Clutch does not weld adjusting rings, but rather discards any rings that are too loose.)

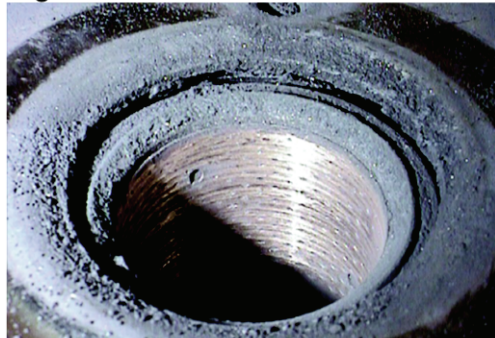
Fig 77

As shown in Figures 77 and 78, incorrect lube or not enough lube can cause a failure. External contamination will also cause wear to the bushing. The transmission input shaft may be rough and require replacement. Use approved/compatible lube. (High quality N.L.G.I #2 or #3 lithium soap grease with E.P. additives 325 degree operating temperature or Roadranger MP-2). Apply ample lube and let it flow out of the opening from the bearing housing. Apply additional lube onto the transmission shaft to ensure the bushing will have proper lube. Apply lube to the tips of the release yoke.
