# Field Service Bulletin Trucks

Date	Group	No.	Release	Page
9.2010	431	001		1(6)

I-Shift Transmission With Mixed Components  
 Version-C  
 AT2512C, ATO2512C, and ATO3112C  
 VN, VHD, VT

## FSB 431-001, I-Shift Transmission With Mixed Components

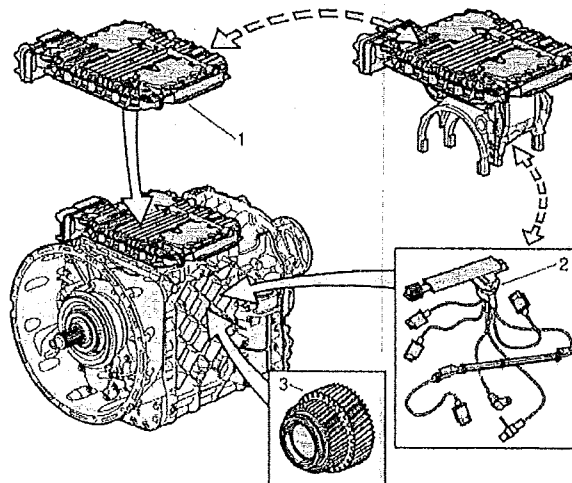
As of June, 2009 the new generation I-Shift transmission (Generation D) was released for production. There are three parts used in combination with the generation D (New) or C (Old) versions of the I-Shift transmissions (see figure below).

1 Transmission Electronic Control Unit (TECU).

TECU-D (New generation)

TECU-C (Old generation)

2 Cable harness including speed sensor.

Speed-sensor-D (New generation)

Speed-sensor-C (Old generation)

3 Sensor wheel.

72 tooth (New Generation)

30 tooth (Old Generation)

**Note:** The difference between the new generation Gear Control Unit (GCU-D) assembly and the old generation Gear Control Unit (GCU-C) assembly is the TECU-D (1) and the new speed-sensor-D (2). The rest of the GCU is equivalent to the old generation.

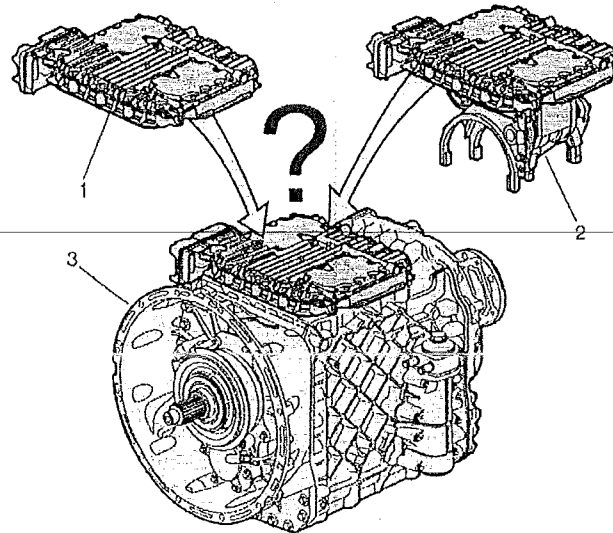
W4059592

I-Shift Generation-C Transmission (AT2512C, ATO2512C, and ATO3112C) Conversion Kit Selection			
Item	Control Unit	Conversion Kit	Parameters
1	TECU-D	85120150	KBQ1, KQR1
2	GCU-D	85120151	KBQ1, KBR0

When installing a replacement part TECU-D or complete GCU-D assembly in an I-Shift generation C transmission, a conversion kit must be run. Follow download of software to MID130, enabling the TECU-D to identify if it is installed in an I-Shift generation C transmission. To select the correct conversion kit, TPI 432-014 and TPI 432-015 have been released. Both are connected to the related part numbers in Impact. The conversion kit will add parameters KBQ and KBR to the TECU-D. By setting these in different combinations the software will identify if either a TECU-D or complete GCU-D is installed in an I-Shift generation C transmission. If the correct conversion kit is not run, a DTC MID130 PID160 FMI1 or FMI2 will result.

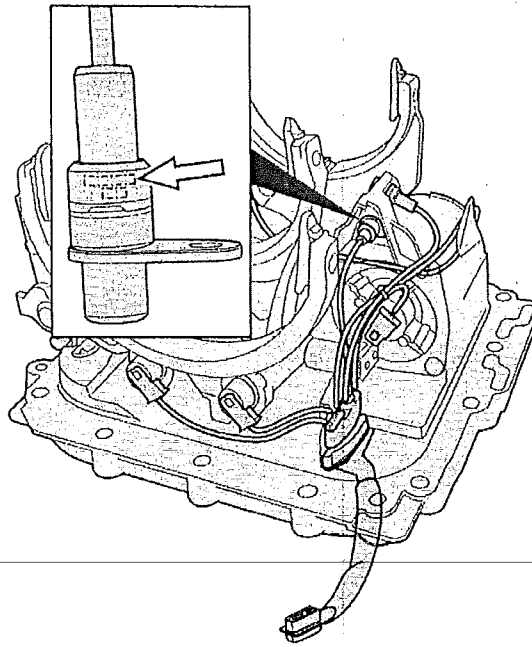
W4059595

The new cable harness includes a new speed-sensor. The cable harnesses are not marked with different part numbers. To identify the speed sensor generation, look at the number stamped on the sensor.

Identify Cable Harness With Speed Sensor			
I-Shift Transmission Version	Cable Harness	Speed Sensor Version	Speed Sensor Number
Generation-C	20775027	Generation-C	4410371001
Generation-D	21068284	Generation-D	4410371051

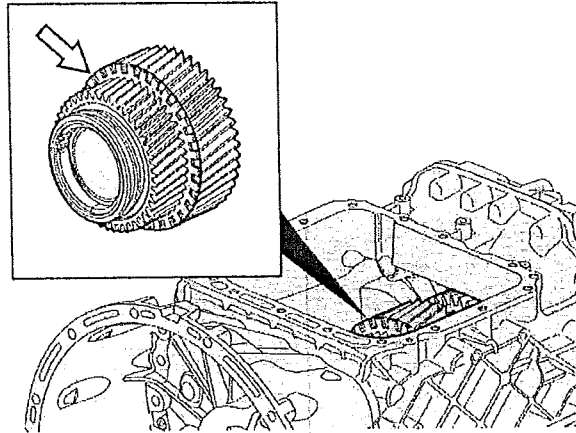
W4059593

For the main shaft there is a new sensor wheel which has 72 tooth compared to the old version which had 30 tooth. The 72 tooth sensor wheel is installed in the I-Shift generation D transmissions and I-Shift generation C transmissions built beginning June, 2009. There will be 72 tooth sensor wheels installed in I-shift generation-C Reman units where a complete GCU-D was installed at remanufacturing.

Sensor Wheel Configuration	
Sensor Wheel Part Number	Sensor Wheel Tooth Number
20542400	30
21034006	72
