Subject: Mechatronic Transmission Module (MTM) Update – Endurant HD and PACCAR TX-12

Document Number: TAIB-1001

Date: July 1, 2022

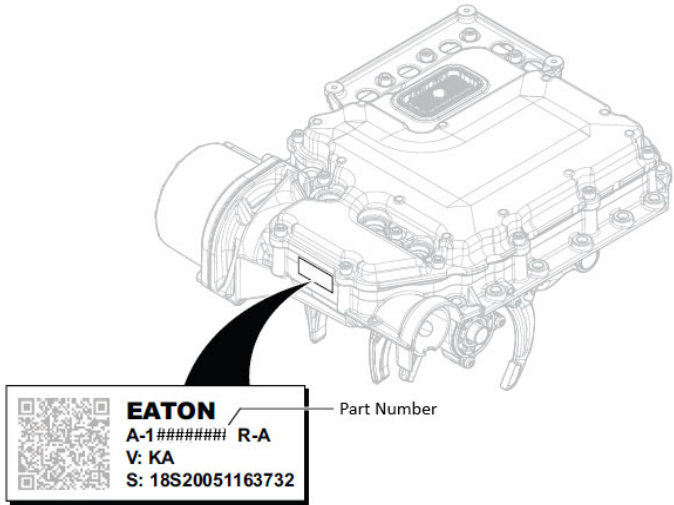
- Procedures include instructions on how to identify MTM Type using MTM part number installed on transmission:

MTM Part Number	MTM Type
A-10000715	PS-393
A-10002594	
A-10004202	
A-10004231	PS-496
A-10004383
