Eaton® Fuller® Heavy Duty Transmissions

Understanding Spur Gear Life

Reference Material TRSM-0913 August 2002

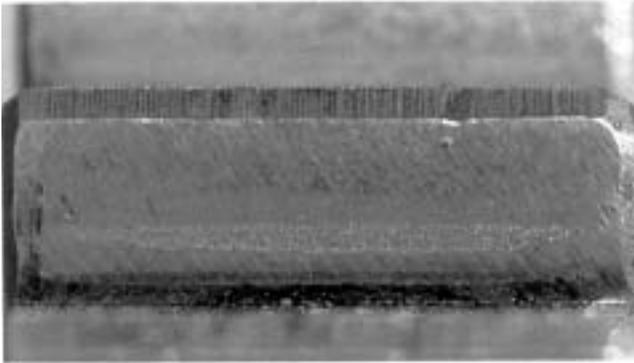
Frosting

As noted before, during mesh specific areas of the tooth surface are in contact during each stage. However, variations in the tooth form between mating teeth may produce a slight change in the contact pattern. This will result in light wear as the mating gears seek to adjust to a common pitch line. Since this wear is in a sliding zone starting near the root of the gear, it causes a form of micro-pitting. Magnification is required to see the pits. To the eye, it looks like a band of off-white discoloration called “frosting”. There is a lack of sheen at this stage.

A gear should not be replaced simply because of frosting. But if it also shows other signs of distress, such as tip loading, misalignment, severe surface irregularities, etc., then further investigation is needed. These signs will be discussed later.

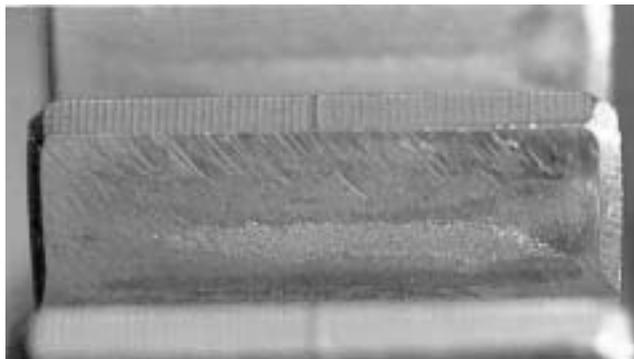
Offset Frosting

As previously stated, there are acceptable tolerances in tooth lead. Mating gear teeth can successfully operate with lead variation in opposite directions. However, a small amount of load shifting may occur. Slight wear may take place until the load is again evenly distributed across the entire tooth width. This may also result in frosting in the dedendum portion and sometimes in the addendum portion of the tooth, offset from the tooth center. Again, under normal conditions, healing will take place and gear life will not be lost.

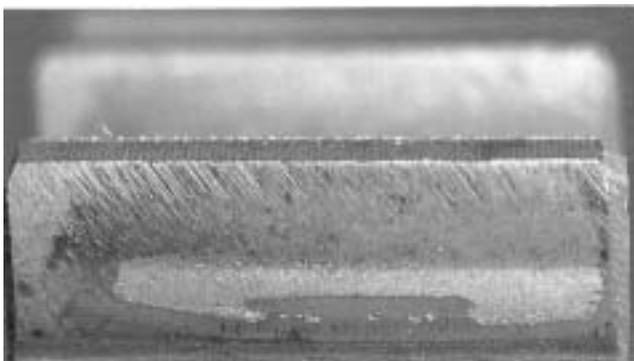
Healing

As seen in the photo, the pitch line is generally well defined. The balance of the frosting will take the shape of the contact area, no matter what it might be. Under normal conditions, the contact zone wears away; the rate of wear decreases until the point is reached where it polishes itself out and the frosting is totally replaced by a very shiny area. No further wear takes place. This is called “healing” and absolutely no gear life is lost at this stage.

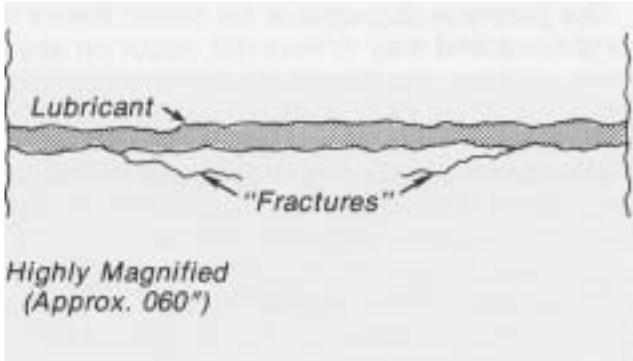
Gear Pitting

There is another surface condition which is normal in the early life of a gear and common in any carburized involute spur gear. It is the result of microscopic variations in tooth form and surface material microstructure.

Lubricant normally fills the irregularities of both teeth while in mesh. Lubricant builds a film of oil and no metal-to-metal contact takes place. Under load, oil pressures and surface stress develop between the teeth. The specific cause of this stress is debatable. One theory is that repeated high horsepower applications may cause oil pressures sufficient to overstress the microscopic areas of the tooth surface. Small surface fractures may start, and repeated loading may increase the fracture until the area is weak enough to break out, forming a pit.

The pit size will vary, depending on the depth of the initial fracture and how far the pitting has progressed. The pitting will progress until the tooth can carry the load without further distress. This rarely exceeds "initial" pitting and the distressed areas can heal

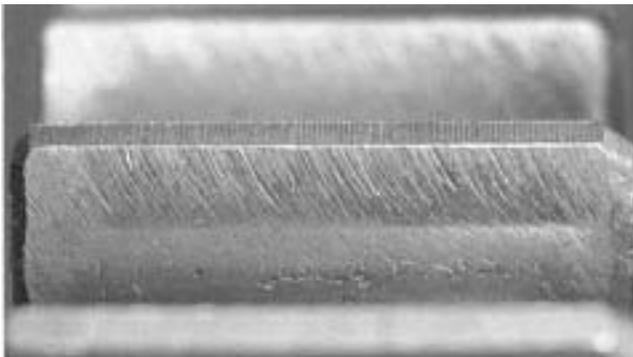
Initial Pitting

"Initial pitting" is the mildest stage of pitting. It consists of definite pits from pin hole size, just larger than frosting and barely noticeable to .030 inches (.762mm) in diameter.

Generally, initial pitting continues until the tooth is able to carry the load without further distress. Do not replace a gear because of initial pitting, as it will not cause noise and in many cases will heal over.

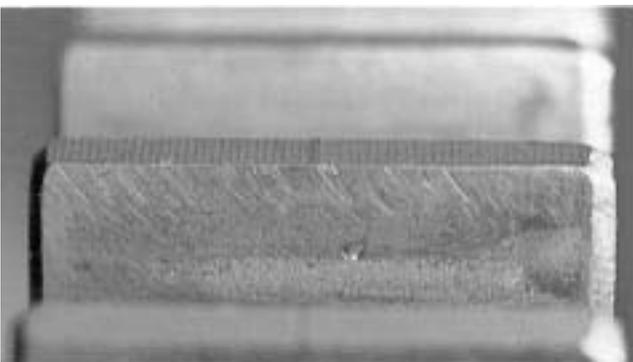
Combinations

You can see under normal operation, a gear can have a "combination" of tooth distress, frosting and/or initial pitting. Again, all are likely to heal over.

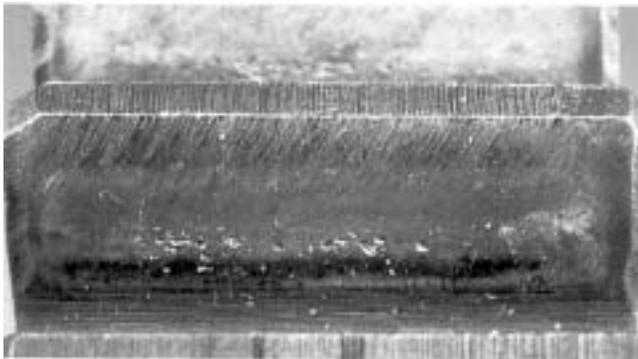
Moderate Pitting

This gear shows pit craters approximately .060 inches (1.524mm) in diameter and .005 to 010 inches (.127mm to .254mm) deep, about twice the size of craters in initial pitting. The pits are widely distributed across the face of the tooth. This gear has lived about 50% of life. The teeth have not been significantly weakened at this stage and there is no danger of breakage. As in the case with gears that show frosting and initial pitting, this type of “moderate pitting” will not cause noise. This gear can give many more miles of useful service.

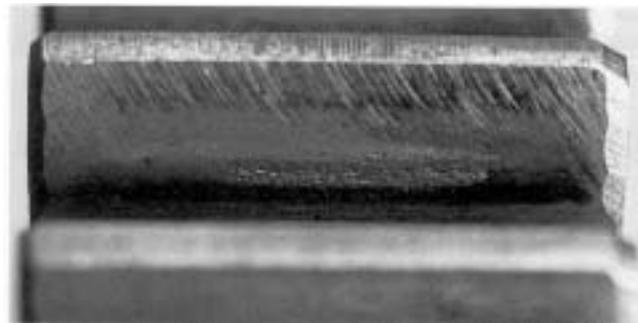
This gear also has pitting on approximately 50% of the tooth surface, but unlike the previous gear shown, this gear should be replaced. The pitting is concentrated and at the pitch line, which changes the involute form. Although the teeth have not been significantly weakened, noise can be generated because the involute form no longer falls within the tolerance band discussed earlier.

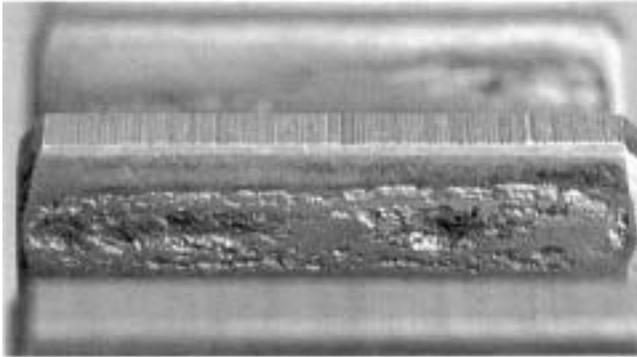
Destructive Pitting

The pitting on this gear is well advanced into a “destructive” stage. The pit craters are considerably larger and deeper than those in moderate pitting. Gears in this stage of pitting should be replaced, or noise and fatigue fractures may occur.

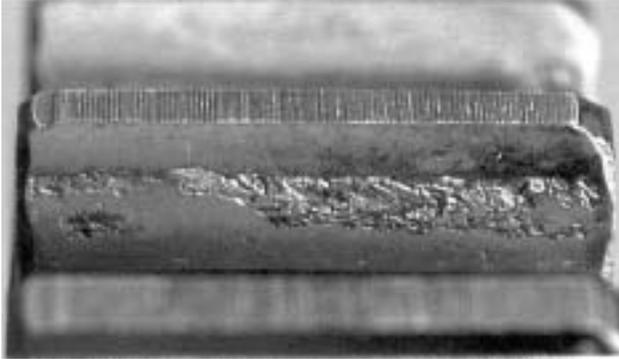
“Spalling” is similar in appearance to destructive pitting except the craters are larger in diameter and shallower in depth. Spalling occurs over a short period of time when a gear is subject to an extreme overload condition.

Major forms of distress are primarily caused by a severe case of the factors given for minor and progressive forms of distress. These forms can occur at any time in the gear's life. Whenever they occur, all gears in the set must be replaced.

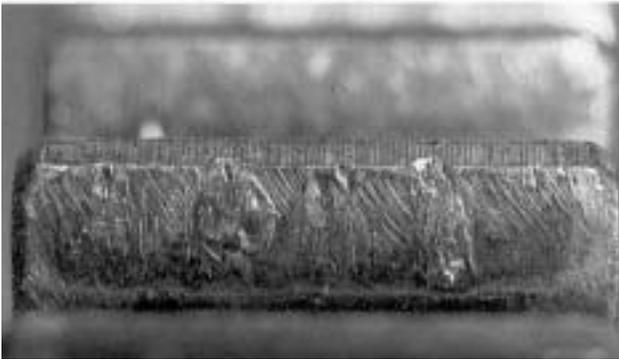
Scoring

“Scoring” is caused by an insufficient oil film between mating gear teeth, resulting in very high surface temperatures. This results in an alternate welding tearing of metal which is rapidly torn from the tooth surface. Insufficient oil film can be caused by: Low oil level, excessive transmission operating angles, high operating temperatures, poor quality, incorrect viscosity oil, and by mixing types of oil.

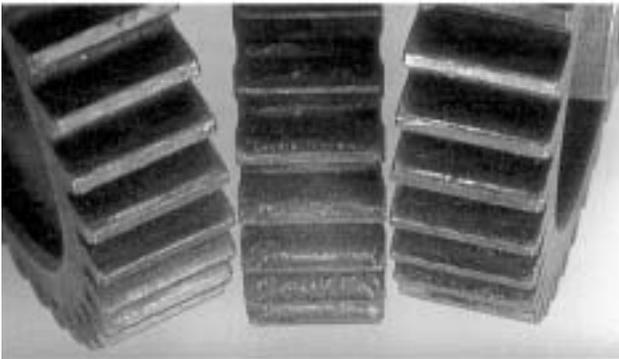
Burned Head Set

When inspecting a transmission with a “burned head set”, it is not unusual to find the main drive gear badly scored, with only slight visible damage to the mating countershaft drive gears. This occurs because the teeth of the main drive gear make contact almost three times as often as the teeth of the mating countershaft drive gears. When replacing a burned main drive gear, also replace the countershaft drive gears, even if there is no visible damage.

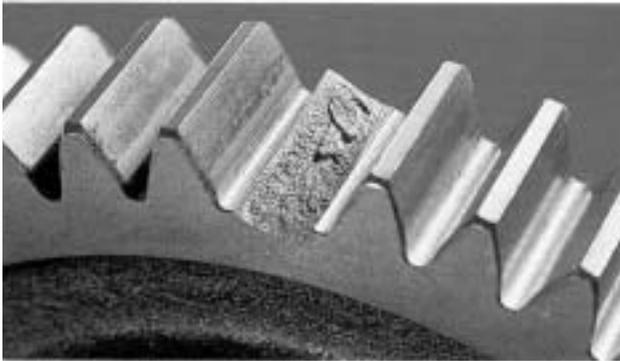
Impact Fractures

“Impact fractures” are caused by a severe shock load or a foreign object passing through the gear mesh. They are identified by a “bump” on the compression side of the fractured area. The more cycles the gear has run after the fracture, the smaller the bump will be. In addition to the gear which has a tooth fracture, the other two gears of the set should also be replaced, even though they may look undamaged. All gearing in the transmission should be inspected for possible damage caused by the broken tooth running through the transmission.

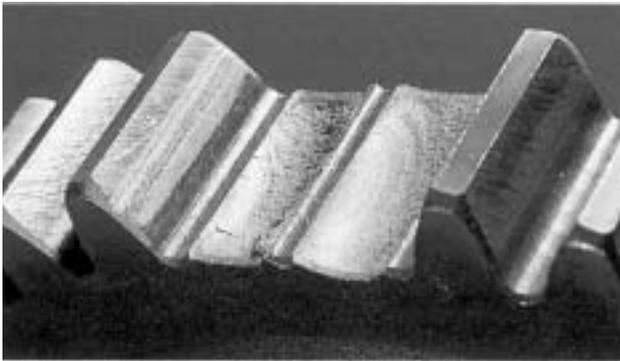
Fatigue Fractures

“Fatigue fractures” are caused by extremely high stresses on a gear tooth over a period of time.

Possible causes of such stresses could be:

- Shock loads causing a small crack in the tooth.
- Tooth damage from objects going through the gear mesh.
- An overload condition.
- Forging imperfections, excessive machining marks, or improper heat treatment.
- Severe pitting or surface fatigue.

Fatigue fractures are identified by “beach” marks on the fractured area. These marks are made as the tooth progressively cracks under a load heavy enough to enlarge the crack but not great enough to break the entire tooth off at one time.

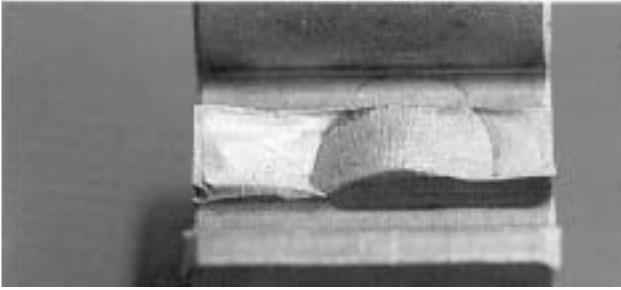
Stingers or Gas Pockets

Gears made from base metal which contain “stringers” or “gas pockets” have weak points at those areas. These fractures can be identified by the difference in fracture shape and metal texture in the break surface. Again, as with other fractures, inspect all gearing in the transmission for possible damage.
