Understanding Spur Gear Life

All Models

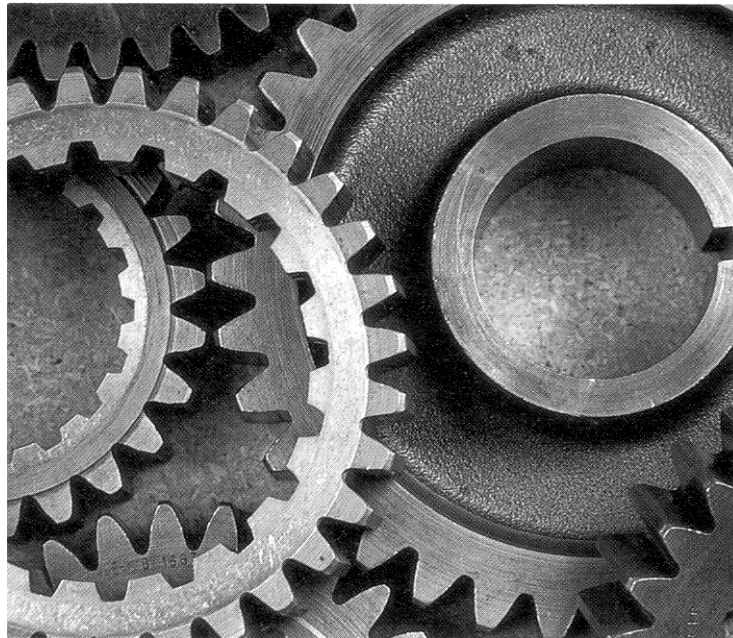
Mechanics of a Spur Gear

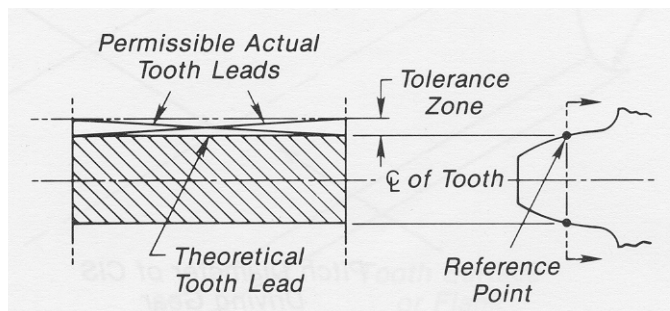
A gear tooth is also designed to be parallel with the centerline of the shaft. As with the tooth profile, certain acceptable tolerances have been determined, as shown in this figure. These close tolerances make it possible to successfully mate gears with lead variation in opposite directions without causing catastrophic failures.

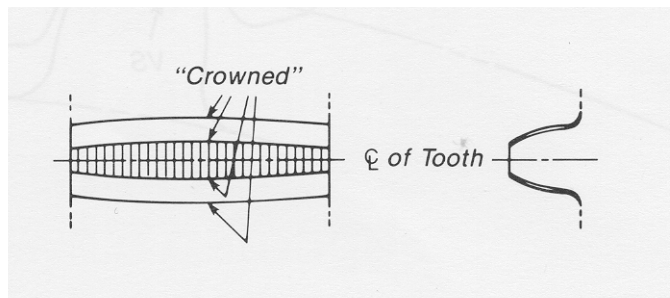
All Eaton® Fuller® transmission mainshaft gearing is "crowned". This figure is an exaggerated representation of the slight curvature machined from end to end on a mainshaft gear tooth. Crowning prevents highly concentrated end loads which might cause surface damage.

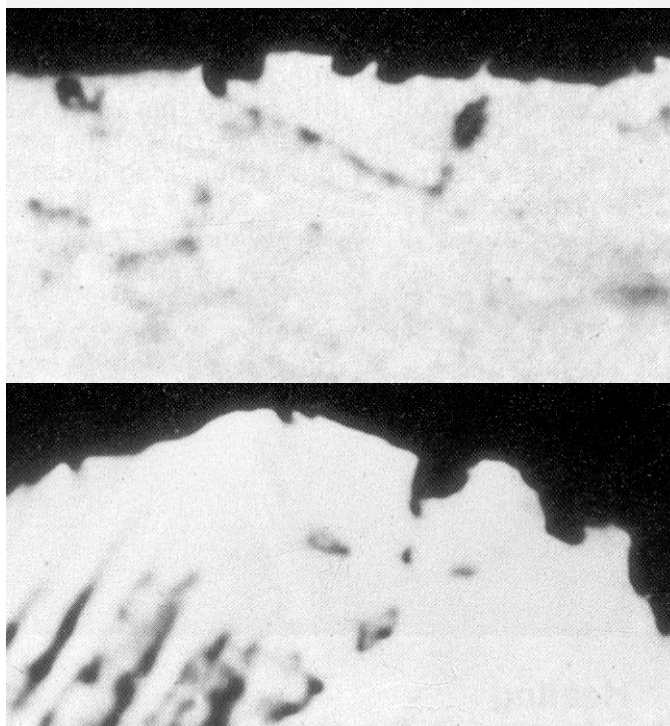
Under magnification, even the smoothest looking surface has irregular hills and valleys. This is illustrated by the two comparative photos magnified 600 times. The top photo shows the pilot bearing surface of the input shaft (.127 mm).

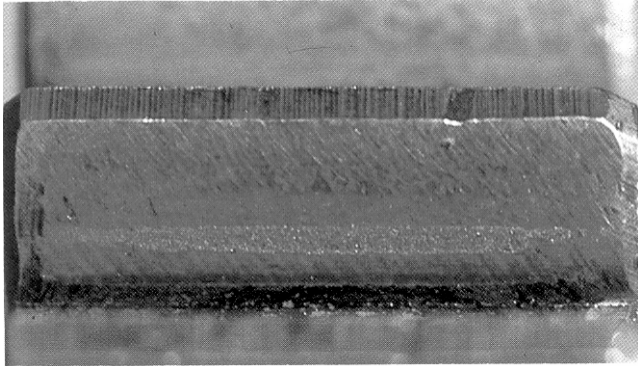
The technical use of the term “distress” in this guideline relates to any changes that may occur on the gear tooth surface; it does not necessarily denote a failure

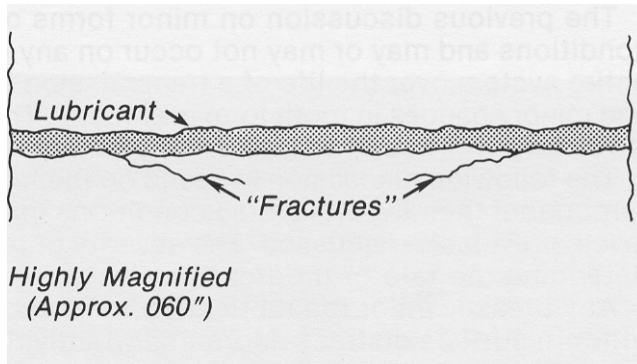
Tooth Surface Distress

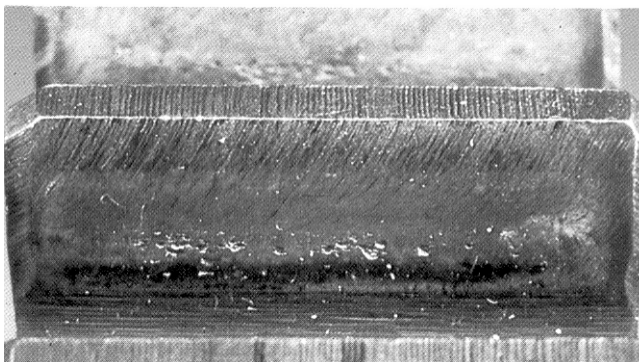
- Low lube level
- Inadequate lube viscosity
- Use of incorrect lube
- Use of oil beyond its functional life

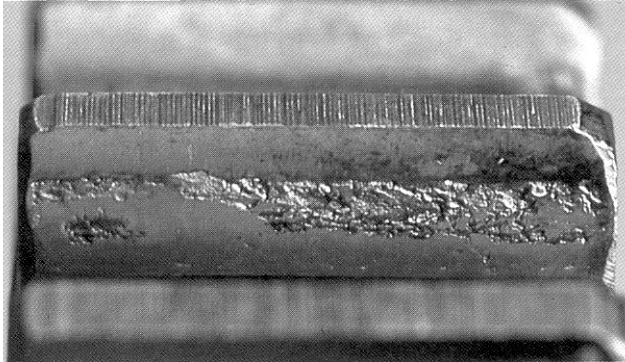
Major forms of distress are primarily caused by a severe case of the factors given for minor and progressive forms of distress. These forms can occur at any time in the gear's life. Whenever they occur, all gears in the set must be replaced.
