Eaton® Clutches

# Failure Analysis Guide

**CLTS1271**

**September 2011**

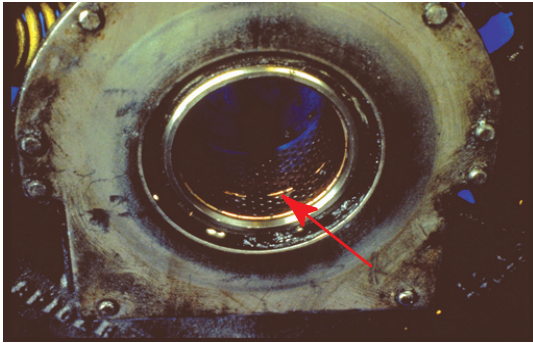
Fig 11

Failure to center the input shaft with the sleeve of the release bearing assembly, when installing the transmission, can cause this failure. If the transmission hangs up during installation, investigate the cause before proceeding as excessive force can damage the bushing (see arrow in Figure 12). Allowing the transmission to hang unsupported in the sleeve bushing can damage the bushing. The arrow in Figure 11 shows another example of sleeve bushing damage on a heavy duty clutch.

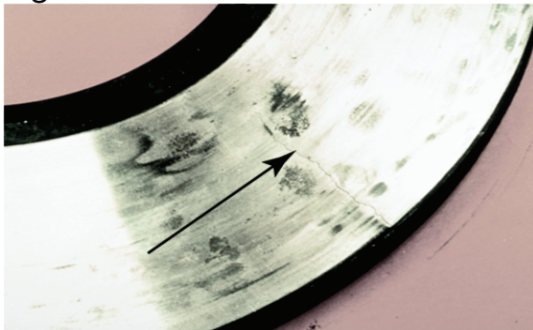
Fig 13

Figures 13 - 16 depict damaged clutch plates which resulted from an abnormal amount of clutch slippage/heat. Some causes of this abnormal slippage/excess heat can be one or more of the following:

Figure 13 is an example of a cracked pressure plate. The heat flow was so great that the metal could not dissipate it quickly enough.

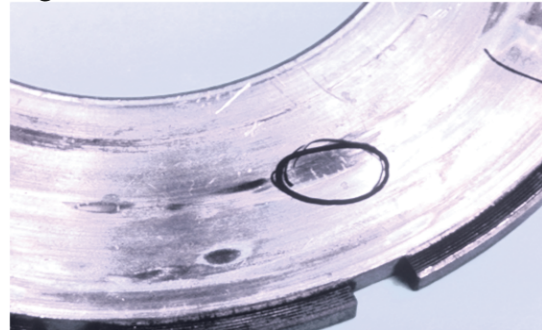
Fig 15

In Figure 15, an area of the intermediate plate has been circled to reveal the damage of heat checks. These heat checks are actually small cracks with raised ridges that are capable of shaving off the facings of the driven disc.

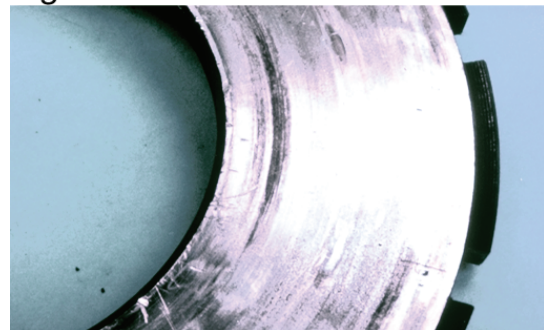
Fig 16

Finally, Figure 16 reveals an example of a burned or scorched intermediate plate in which the metal became so hot that it began to flow. The typical evidence of such a failure will be one or more of the following:

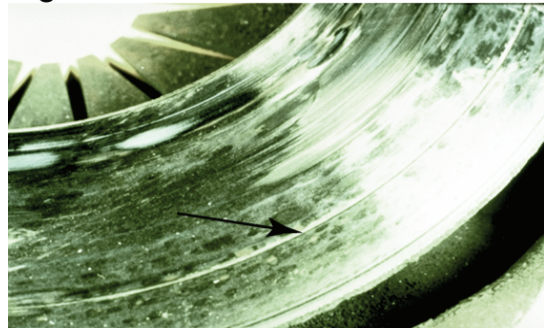
Fig 17

The groove (see arrow in Figure 17) worn into the face of this pressure plate was caused by the rivets of the driven disc facing. (For the related disc failure, see the description under Figure 70). The same damage can occur on both the intermediate plate and flywheel. A surface that is grooved can damage the new driven discs that are installed. As a result, a new clutch assembly should be installed. Refer to the OEM service manual concerning fly-wheel resurfacing.

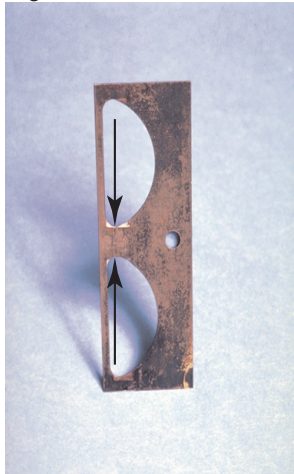
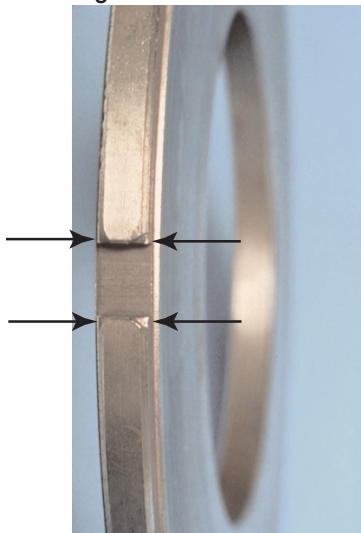
As shown in Figures 23 and 24, the intermediate plate was “hanging up” at the corners of the open sections of the anti-rattle springs. The driver’s complaint was a clutch that would not release. It is important that the rounded sections of the anti-rattle springs be installed TOWARDS the flywheel/ engine.

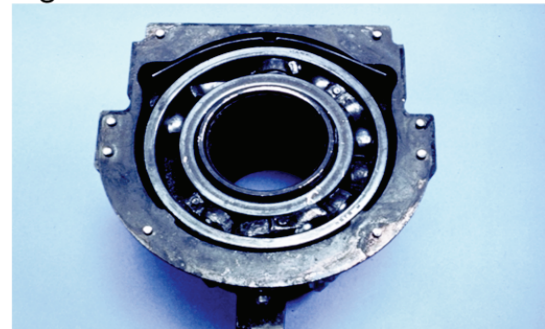
Fig 28

A failed release bearing (see Figure 28) can usually be attributed to one or more of the following situations:

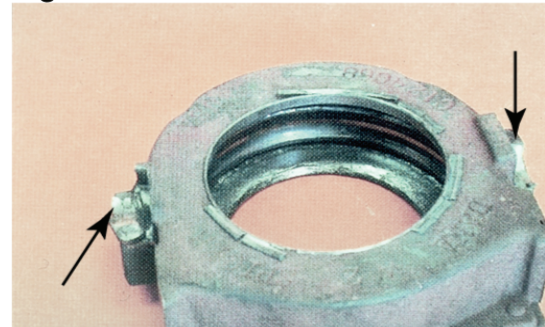
Fig 29

- A dry release bearing due to lack of periodic lubrication (does not apply to sealed bearings).
- Failure to fully release or riding the clutch pedal will place a constant thrust load on the bearing, (see arrows in Figure 29) leading to higher temperatures and consequential loss of lubricant. Failure to maintain free play up in the cab can also cause this condition. Not only will the bearing begin to fail, constant contact in this area will cause both the release yoke fingers (Figure 79), and the wear pads (Figure 29), to wear excessively.

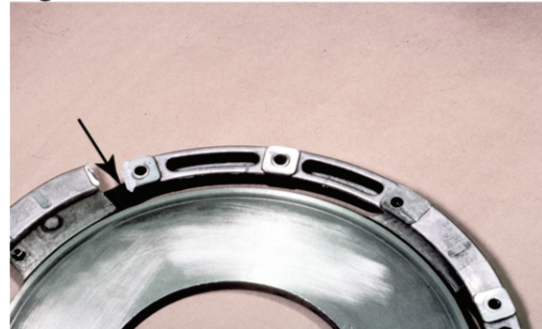
Fig 34 (SAS)

As shown in Figure 34 (see arrow), the aluminum spacer ring broke when it was bolted up backwards onto the flywheel.

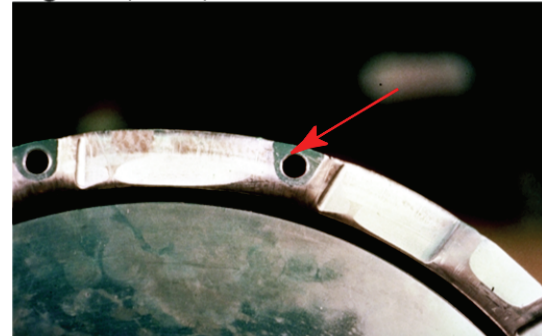
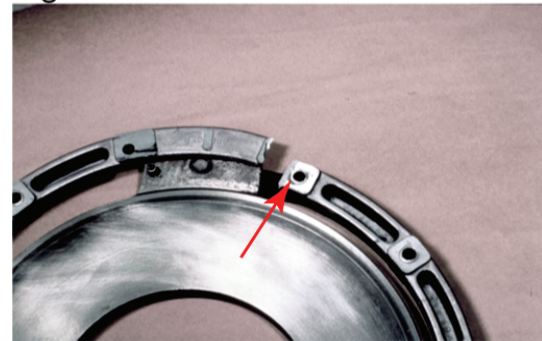
**Note:** The cover assembly mounting hole pads (see arrow in Figure 35) have made an indentation (see arrow in Figure 36) onto the spacer ring mounting hole pads (flywheel side). This evidence will confirm that the spacer ring/intermediate plate assembly was indeed installed backwards. The words "Flywheel side" (refer to Figure 37) will face the flywheel when properly installed. Mishandling of this assembly during installation and/or removal can also cause the spacer ring to break. Some results of installing the intermediate plate backwards are as follows:

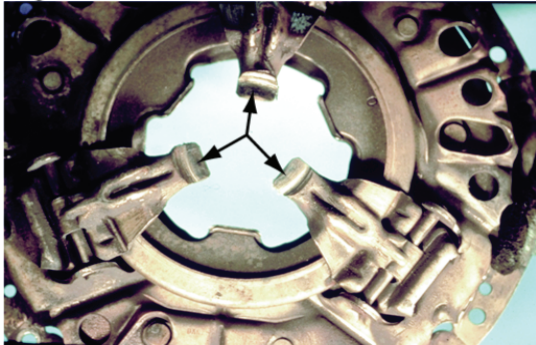
Fig 38 (AR)

- A throw out bearing which fits too tightly on the front bearing cap stem. As a result, the return spring(s) (attached to the linkage or throw-out bearing) may not be capable of retracting the throw-out bearing away from the clutch levers. This will cause contact between these parts.
- Worn and/or binding linkages are causing the throw-out bearing to make “constant contact” with the clutch’s three (3) release levers (Figure 38).
- Using a throw out bearing of inferior quality.

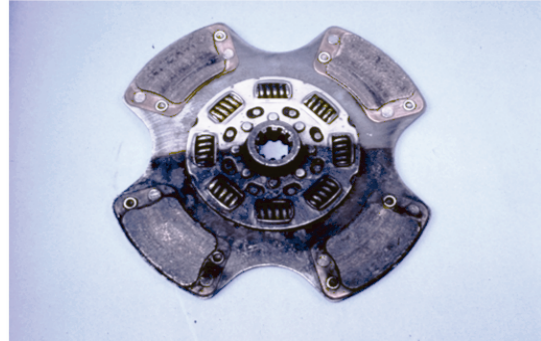
Fig 41 (AR)

A leaking transmission or a leaky rear main engine seal can coat the clutch cover with oil, as indicated in Figure 30. Figure 41 shows the disc which was run with this cover.

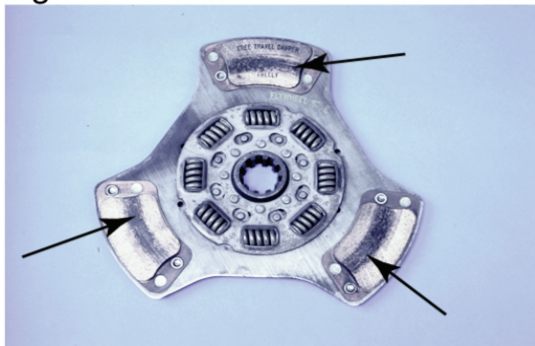
Fig 46

The exception to the above wear pattern is described in detail in Figure 46. The title of this description is: "Failure - Abnormal wear pattern at middle of disc button".

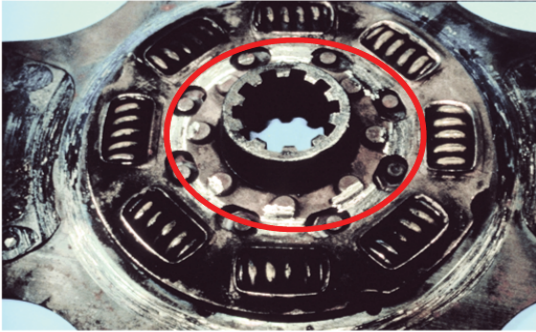
Fig 57

Figure 25 shows the damage done to the nose of the retainer assembly (see arrow) due to contact with the disc rivets. Figure 57 shows the resulting damage done to the rear disc. Adjusting the clutch externally (with the linkage) instead of internally (rotation of adjusting ring) will cause the retainer sleeve/release bearing assembly to move too far forward as the clutch wears, leading to this failure.

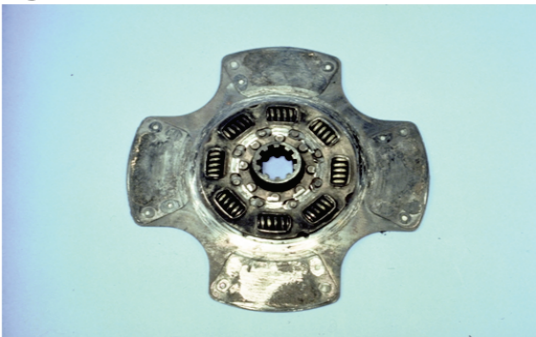
Fig 58

An additional result from the above failure is that while the clutch is engaged, it can begin to slip due to the unloading condition created by the disc and retainer interference. This, in turn, will create excessive heat and can cause the pressure plate to break (see Figure 25, black arrow on pressure plate) and/or the ceramic buttons to separate from the disc (see Figure 58). The above failure may also be preceded by a noise complaint.

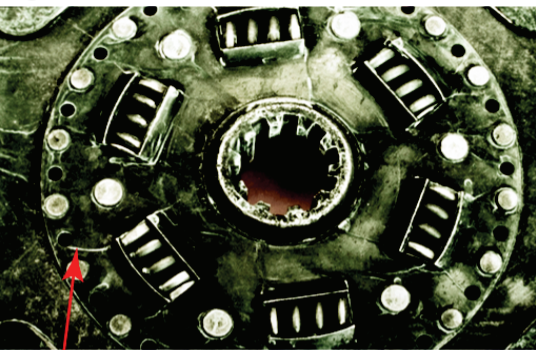
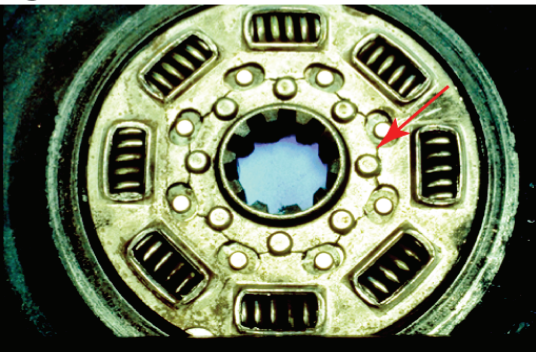
The cracks shown in Figures 59 and 60 (see arrows) can result from:

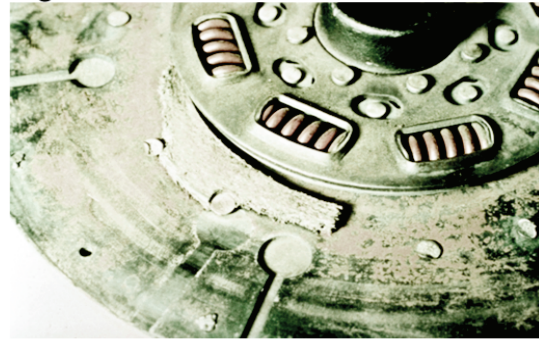
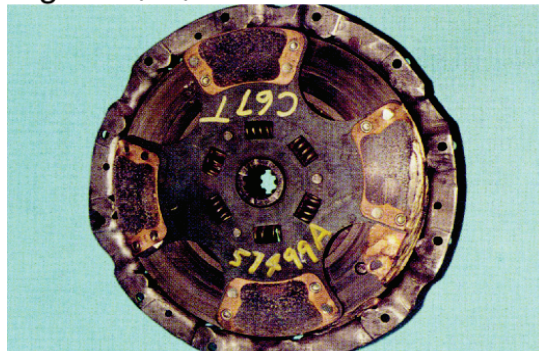
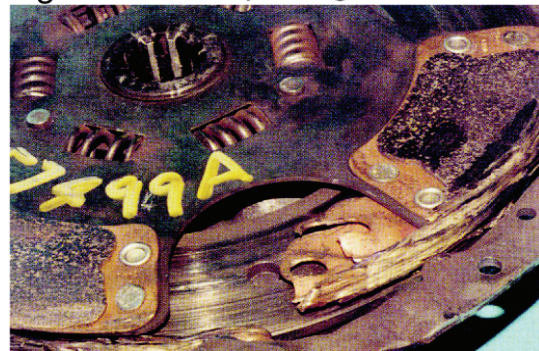
Example: Coasting a tractor down an unloading ramp can burst a driven disc. See Figures 67, 68, and 69.

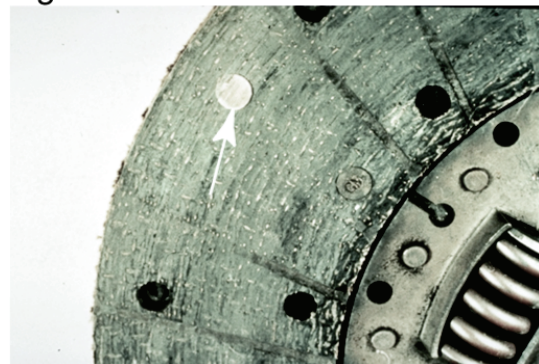
Fig 70

When the rivets (those which secure the facing material to the driven disc) begin to contact either the pressure plate, intermediate plate, or flywheel, then the entire clutch assembly is ready for replacement. Referring to the arrow in Figure 70, this rivet has been making contact with the pressure plate shown in Figure 17. Note the "shiny" appearance of the rivet and also the resulting "groove" on the pressure plate.

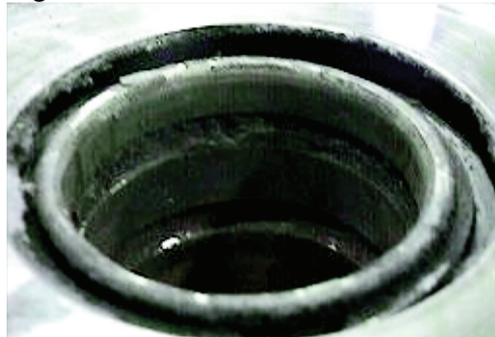
Fig 78

- A potential result of this wear is that the release yoke will force the bearing and sleeve assembly against the input shaft. Consequently, this “side loading” condition can damage the bushing, sleeve, and input shaft (see Figure 78).

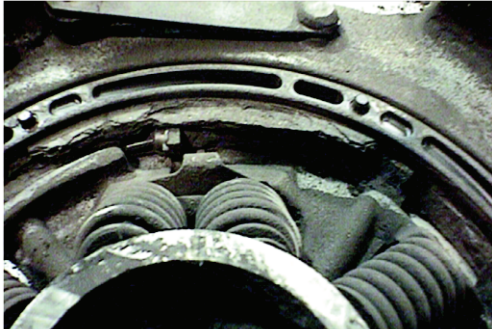
Fig 80

## **Failure - Solo Adjustment Rings Contaminated - Solo Stops Adjusting**

If there is excessive amounts of contamination allowed into the clutch housing, the Solo may stop adjusting and there will be a loss of free pedal in the cab (see Figure 80). Check to see if the inspection cover has been removed. In severe dust applications, it may be necessary to seal all openings in the clutch housing.

Eaton has created a tool that may help free up the clutch to allow it to continue adjusting. #CLPISOLOTOOL can be obtained by calling 800-826-HELP (4357).

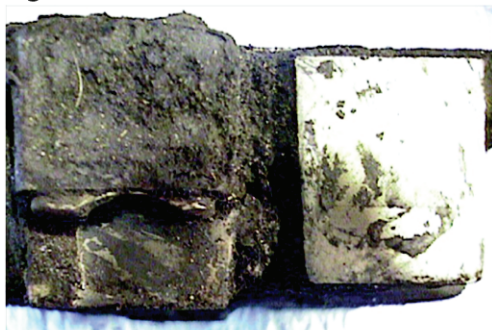
Fig 81

## **Failure - Worn Wear Pad on Release Bearing caused by Running the Truck without Free Pedal**

When the clutch is properly maintained, there should always be free pedal in the cab. This will prevent fork contact with the bearing wear pads and reduce the wear to the pads and the release fork (Figure 81). Follow adjustment instructions for correct clutch and linkage adjustment. Adjust the clutch before free pedal is lost. Apply grease to the yoke fingers to reduce friction when the clutch pedal is stroked.

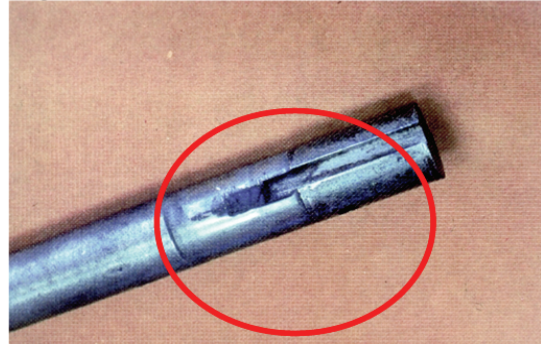
Fig 82

### Failure - Cross Shaft Wear

Figure 82 is an example of a worn cross shaft (release shaft). A worn cross shaft (see circle) will occur after high mileage and will be accelerated by a lack of lubrication. Some problems associated with worn cross shafts (and/or worn linkage systems) are:

- Sporadic changes in the amount of free play in the cab
- A binding condition in the linkage system
- Erratic engagement of the clutch
- Side loading of the release bearing housing

As a result, a typical complaint might be that it is impossible to maintain proper clutch adjustment. To prevent future clutch problems, always inspect the linkage system for excessive wear and/or binding conditions before installing the new clutch. Be sure to replace any worn components that might hinder clutch operation. Also, remember to lubricate the linkage pivot points.

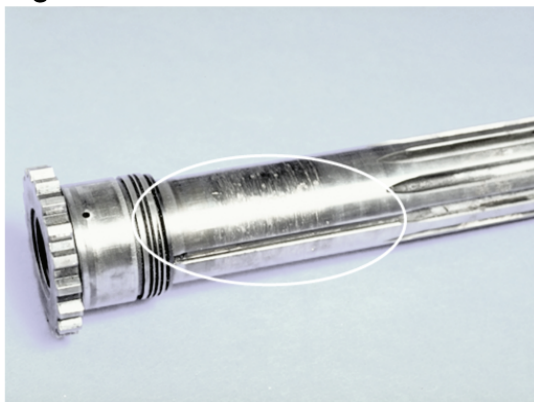
Fig 85

## Failure - Galled Input Shaft

This failure resulted when the clutch's release sleeve was being “side loaded” onto the input shaft (Figure 85). A worn linkage system and/or excessive wear on the release bearing “wear pads” and “release yoke fingers” can cause this side loading condition.

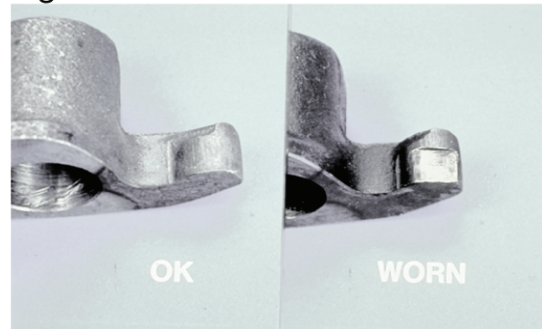
Fig 86

### Failure - Worn Fingers on Release Yoke

Consequently, there will be continual contact between the release yoke fingers and the release bearing wear pads. A yoke that is worn excessively may hinder the engagement/control of the clutch. See Figures 1, 5, and 10 for additional photos and descriptions of release yoke failures.
