# Field Service Bulletin Trucks

Date	Group	No.	Release	Page
9.2010	431	001		1(6)

I-Shift Transmission With Mixed Components  
 Version-C  
 AT2512C, ATO2512C, and ATO3112C  
 VN, VHD, VT

## FSB 431-001, I-Shift Transmission With Mixed Components

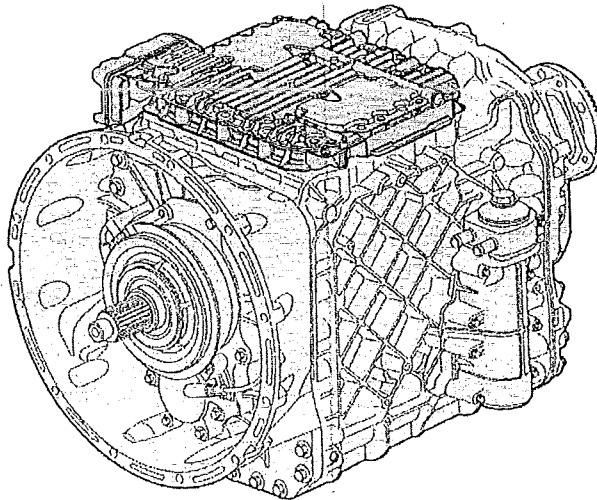
W4059589

As of June, 2009 the new generation I-Shift transmission (Generation D) was released for production. There are three parts used in combination with the generation D (New) or C (Old) versions of the I-Shift transmissions (see figure below).

1 Transmission Electronic Control Unit (TECU).

TECU-D (New generation)

TECU-C (Old generation)

2 Cable harness including speed sensor.

Speed-sensor-D (New generation)

Speed-sensor-C (Old generation)

3 Sensor wheel.

72 tooth (New Generation)

30 tooth (Old Generation)
