# **UltraShift PLUS Automated Transmissions TRTS0940 EN-US**

February 2021

UltraShift® *PLUS* Linehaul Active Shifting (LAS)  
UltraShift® *PLUS* Linehaul Small Step Efficiency (LSE)  
UltraShift® *PLUS* Multipurpose Extreme Performance (MXP)  
UltraShift® *PLUS* Multipurpose High Performance (MHP)  
UltraShift® *PLUS* Vocational Active Shifting (VAS)  
UltraShift® *PLUS* Vocational Construction Series (VCS)  
UltraShift® *PLUS* Vocational High Performance (VHP)  
UltraShift® *PLUS* Vocational Multipurpose Series (VMS)  
UltraShift® *PLUS* Vocational Extreme Performance (VXP)  
UltraShift® *PLUS* Passenger Vehicle (PV)

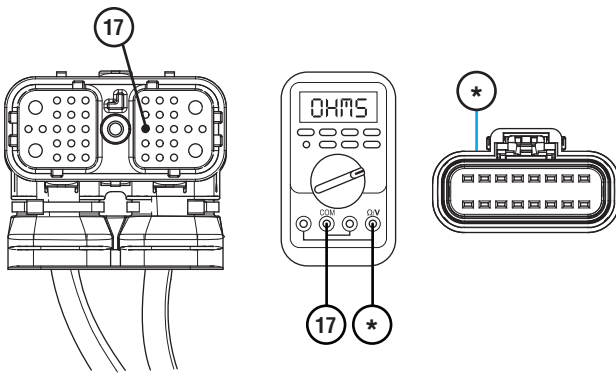
2. Measure resistance between 38-Way Vehicle Harness Connector Pin 17 and corresponding neutral request return pin at the OEM J1939 Shift Control Connector. Record reading(s) in table.
