EndurantTransmission

TRTS0950 EN-US

General Information

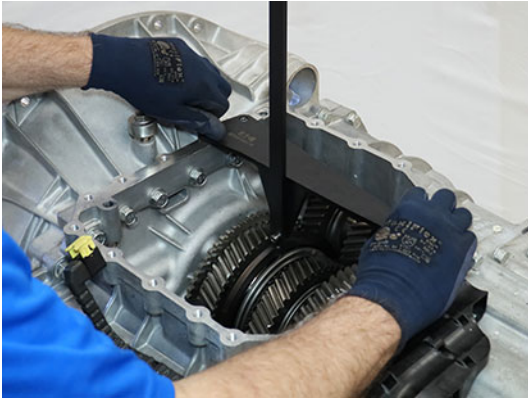
1. Install the Rail B Engagement Tool (RR1088TR) to the Main Housing and hand tighten with 2 MTM cap screws.
