Manual TP-0445

Parts Failure Analysis

Revised 06-13

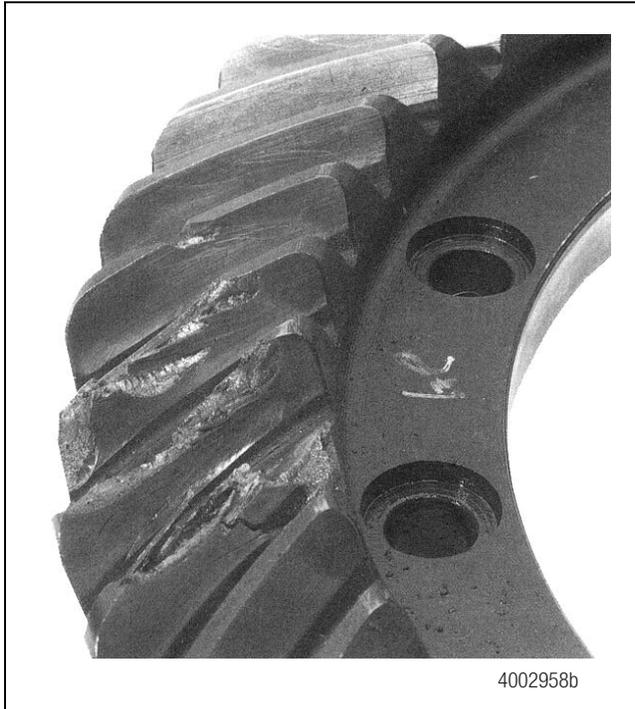
Figure 1.1

This publication provides a parts analysis process to help you determine why parts failed during operation, what to look for when you inspect parts, and how to help prevent failures from occurring again. Figure 1.1, Figure 1.2 and Figure 1.3 are examples of failed parts.

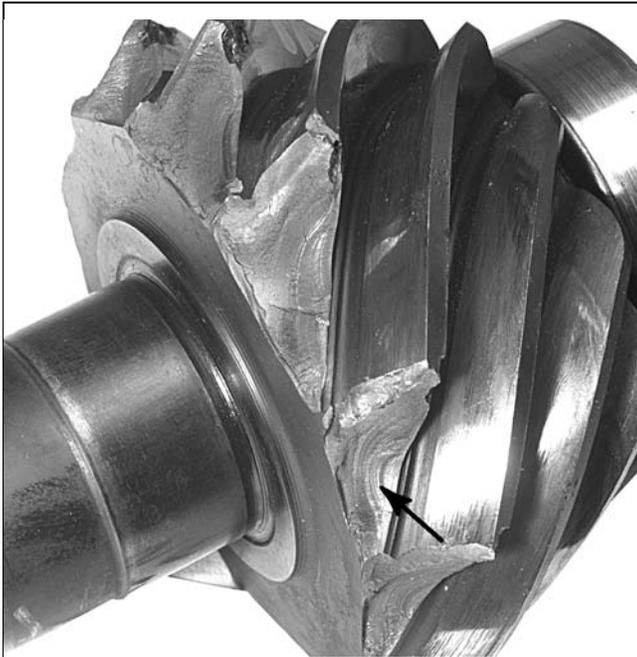
TEETH BROKEN DUE TO FATIGUE AT HEEL END

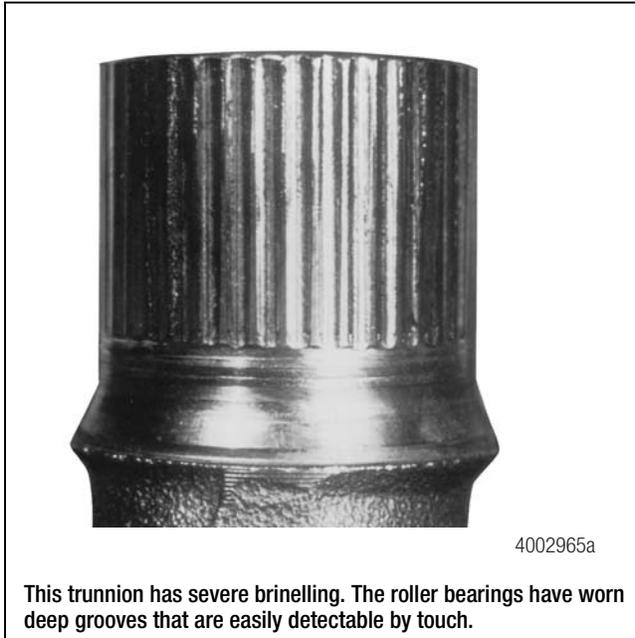
Figure 3.6

Brinelling is a type of surface fatigue that causes bearing rollers to wear deep grooves into the mating surface. Figure 3.6. Brinelling of a u-joint usually occurs when load applications exceed the vehicle’s rating, which can also cause parts to spall from uneven load application.

Brinelling can also be caused by overloads on undersized u-joints and by a breakdown of lubricant between the needle rollers and trunnion. To determine if the condition you see is brinelling, check the trunnions with your fingertips. Do you feel deep grooves? If so, brinelling has occurred.

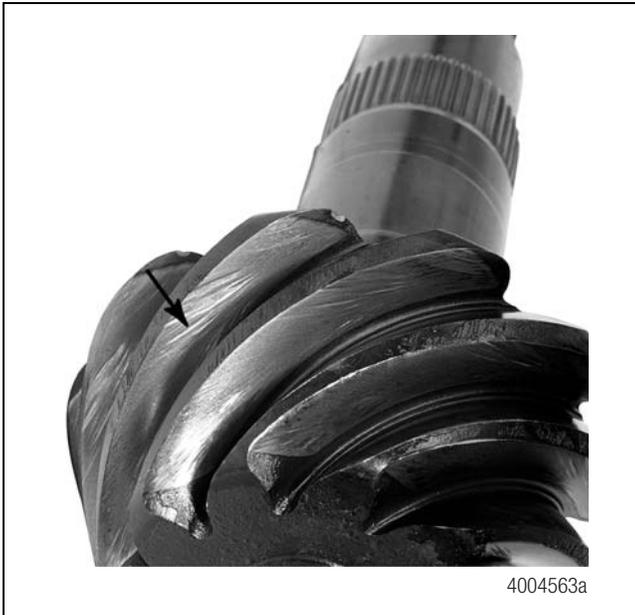
Crow's footing is a type of surface fatigue that runs lengthwise on hypoid and amboid bevel gear teeth. Crow's footing occurs when the vehicle operates with insufficient or incorrect lubricant. Metal-to-metal contact occurs, which causes friction to damage parts. Figure 3.9 and Figure 3.10.

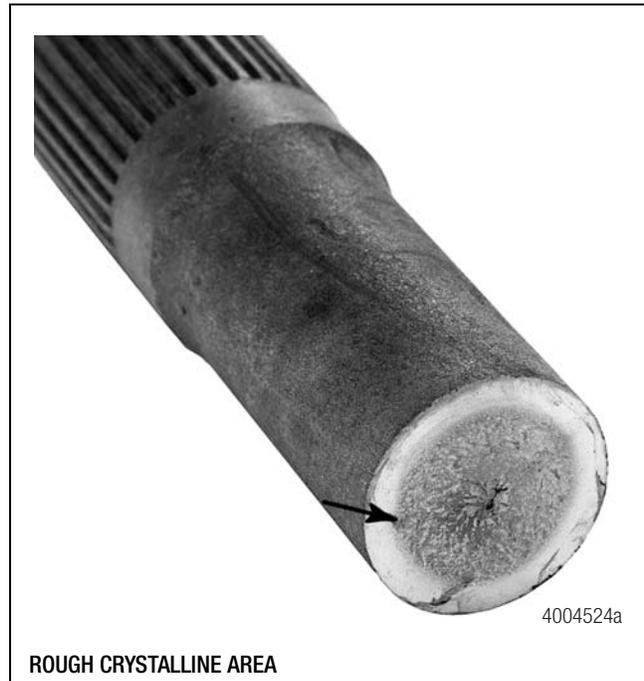
Figure 3.11

When a sudden, severe impact load occurs, the wear pattern that forms on the surface of the part resembles crystal facets. Figure 3.11.

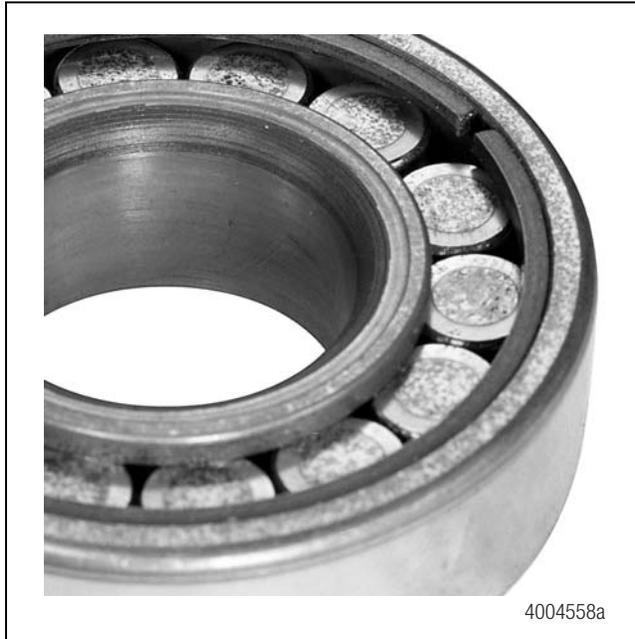
Water in lubricant damages bearing races and cups, and causes the hypoid gear set to wear prematurely. Figure 3.12 shows corrosion on the spigot bearing roller ends. Figure 3.13 shows etching damage on the bearing rollers, non-contact surfaces and bearing cage windows.

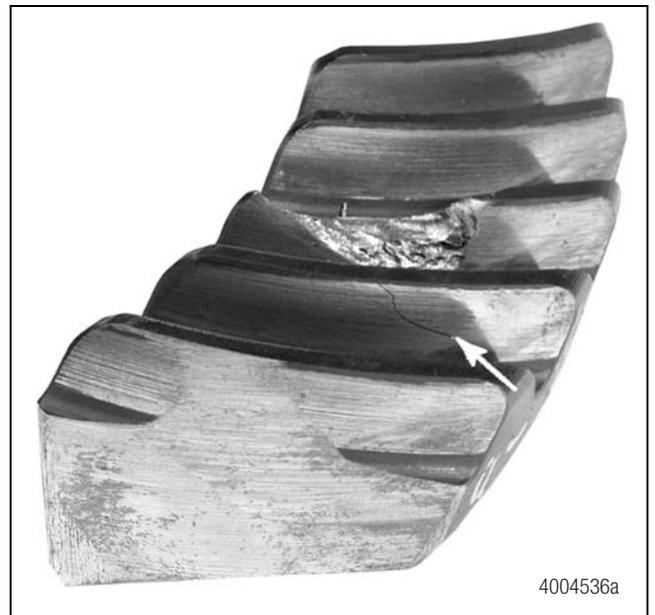
Figure 3.14

Flank cracking is a type of surface fatigue that's similar to spalling, because it causes metal to break into chips or fragments. When flank cracking occurs, initially cracks form along the length of the gear tooth. Once flank cracking appears, the tooth begins to crumble, and failure rapidly occurs. Figure 3.14.

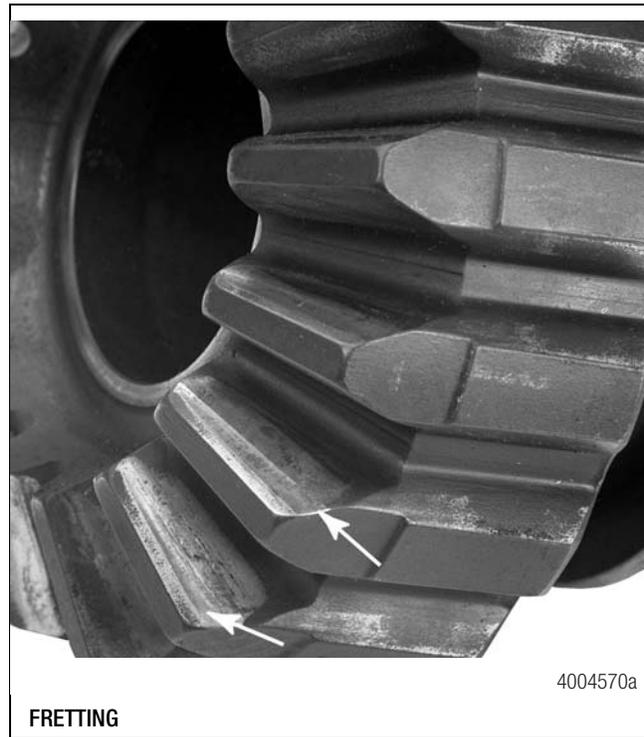
Figure 3.16

Inspect the back of the gear teeth on the forward drive axle carrier. If you find a contact line on the rear side of the gear teeth on the forward drive axle carrier, fretting has occurred. Figure 3.16.

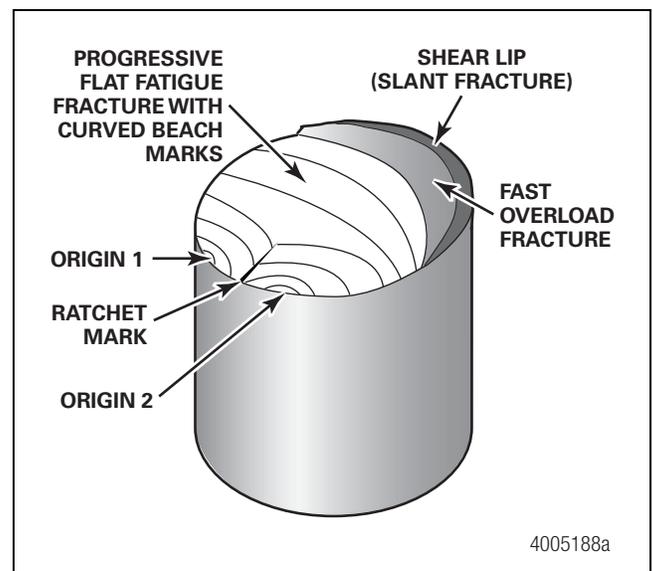
Figure 3.23

When more than one fatigue fracture occurs, beach marks form and create a raised, rough "ridge" between the origins of the fractures. This ridge is called a "ratchet mark." In this figure, you can see the ratchet mark between the first fracture, (Origin 1), and the second fracture, (Origin 2). Figure 3.23.

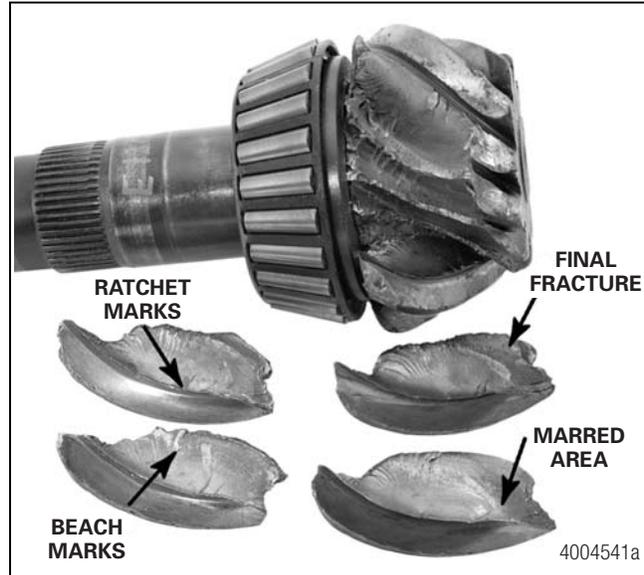
Figure 3.25 shows a less common root beam fatigue fracture that occurred when shock load was strong enough to crack the tooth, but not to break the entire tooth.

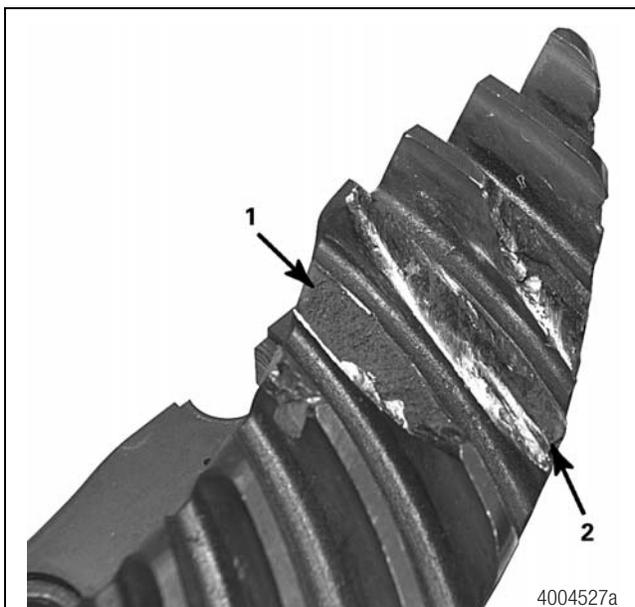
Figure 3.27 shows a hypoid gear seat damaged by shock load. Typically, the first tooth breaks at the heel, the second tooth breaks completely, and the third tooth breaks at the toe. The figure shows how two of the teeth were damaged by the pinion rubbing against the area where the teeth broke.

1 ROUGH CRYSTALLINE AREA
2 SMEARED AREA

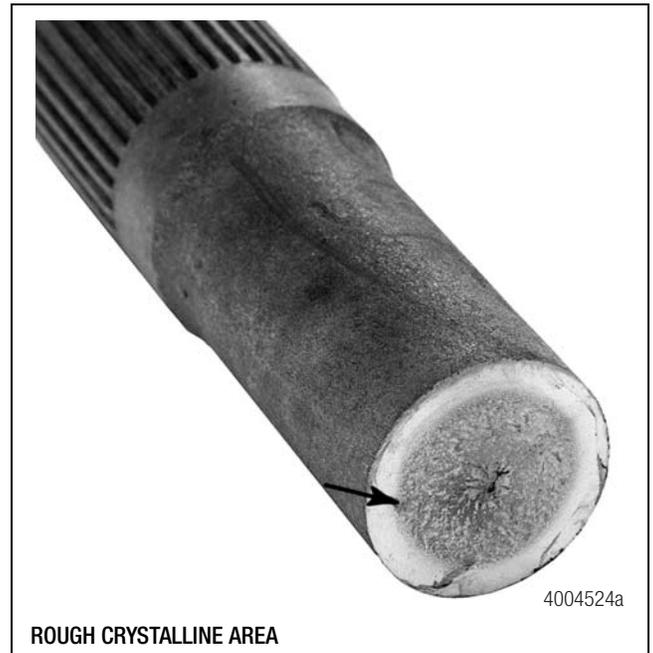
Figure 3.28 and Figure 3.29 show an axle shaft damaged by shock load that fractured perpendicular to its centerline, which caused a rough, crystalline surface to form on the shaft. This type of failure is also called "torsional shear." If the fracture is at a 45-degree angle to the centerline, the damage is called "torsional tensile" failure.

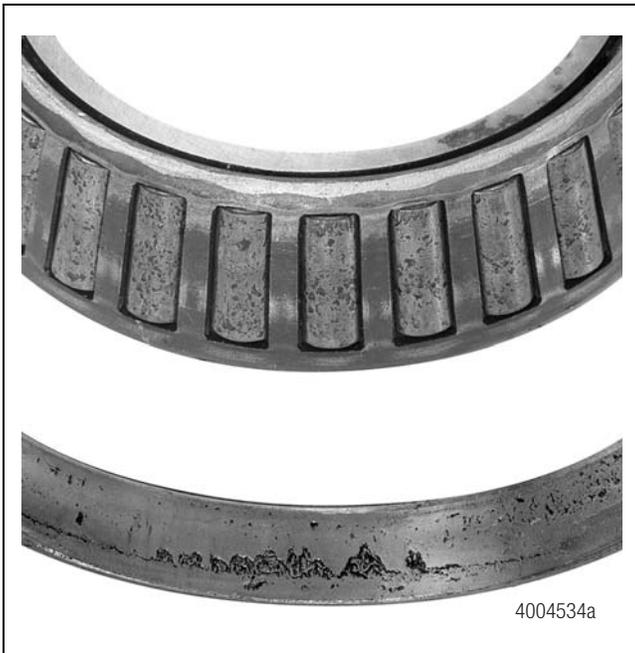
Some causes of spalling are prolonged stress from excessive load applications; or the components operate with no lubricant or a lubricant that doesn't meet the correct specification. Spalling can also occur when components are operated beyond the maximum mileage range. Figure 3.30 and Figure 3.31.

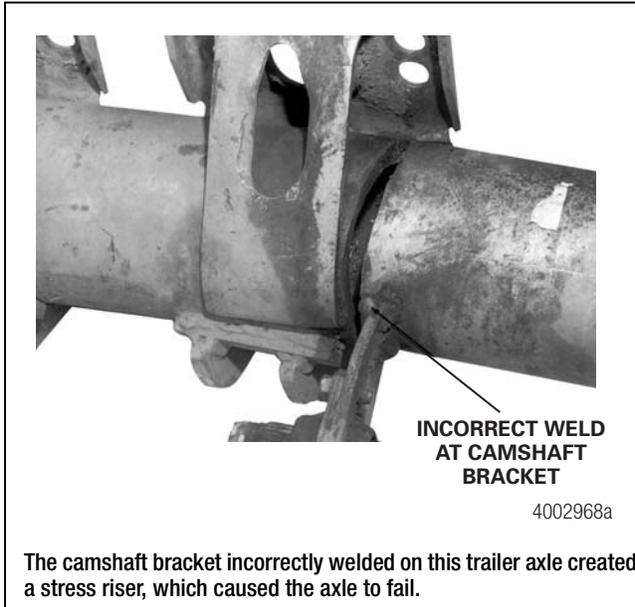
Figure 3.32

A stress riser is a condition caused by fatigue that deforms metal on a component's surface. For example, welding on an axle creates intense heat that changes the characteristics of the metal that surrounds the weld, and an incorrect weld caused fatigue to occur. In Figure 3.32, you can see that fatigue had created a stress riser, which caused the axle to fail.

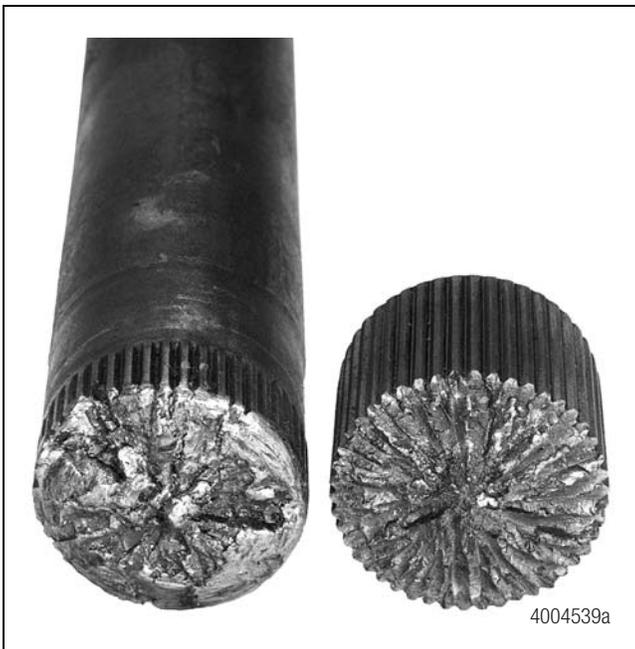
Unlike bending fatigue, torsional fatigue causes excessive twisting that weakens components. Usually, you'll see beach marks and ratchet marks at the fracture's origin point. However, if torsional fatigue occurs on a splined shaft, you'll see that the fracture started at the base of each spline. Figure 3.36 shows a drive shaft damaged by torsional fatigue. As the splines continued to weaken, the metal formed a star-shaped radial pattern, eventually breaking the shaft at the center.

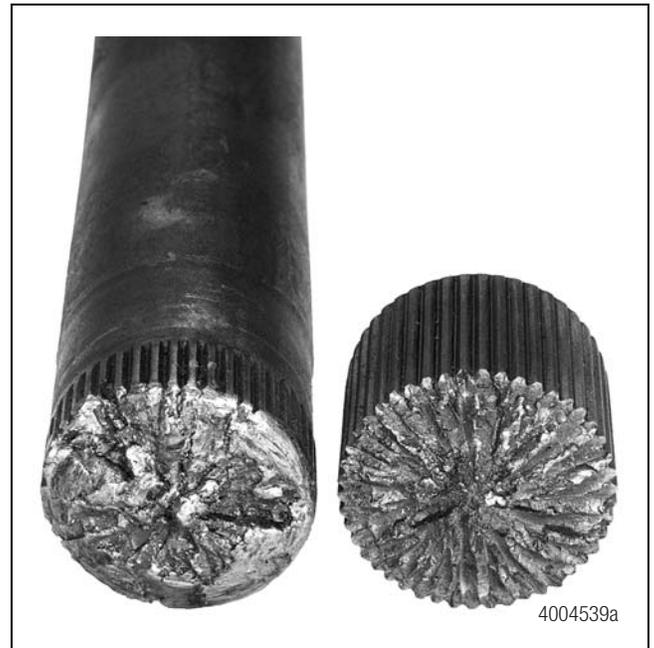
Figure 4.5 shows a shaft damaged by torsional fatigue. As the splines continued to weaken, the metal formed a star-shaped radial pattern, eventually breaking the shaft at the center.

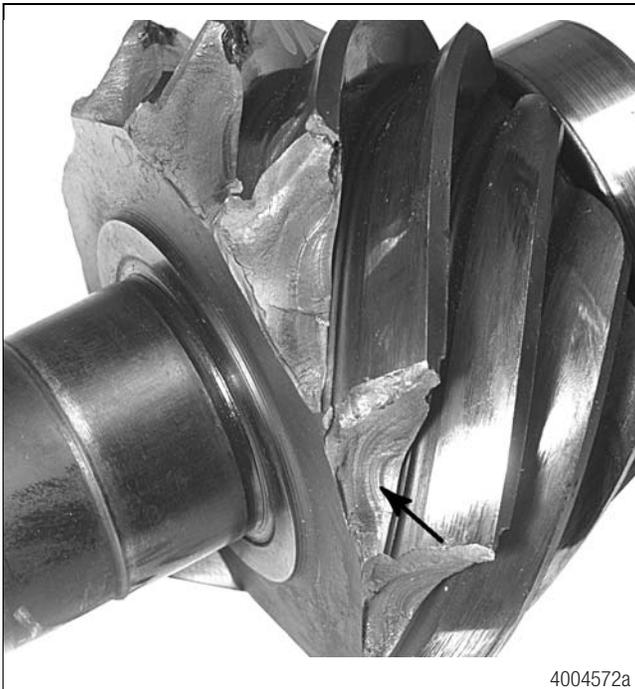
Figure 4.7

TEETH BROKEN DUE TO FATIGUE AT HEEL END

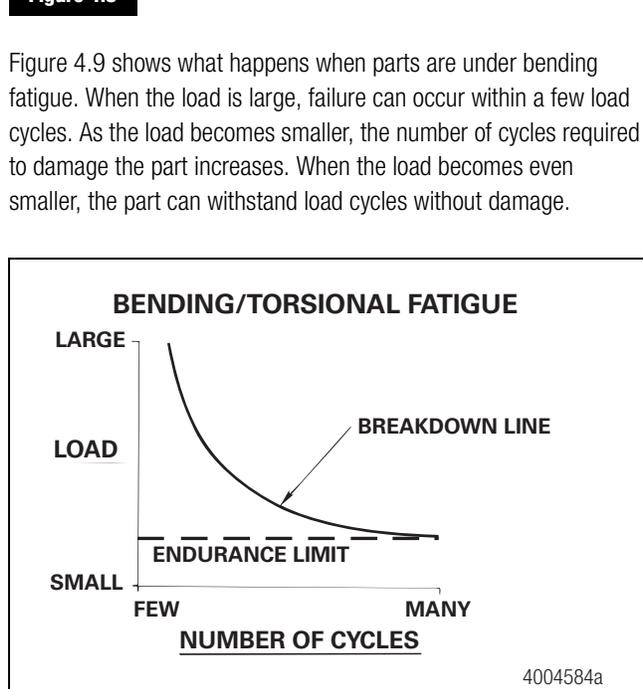
Figure 4.9 shows what happens when parts are under bending fatigue. When the load is large, failure can occur within a few load cycles. As the load becomes smaller, the number of cycles required to damage the part increases. When the load becomes even smaller, the part can withstand load cycles without damage.

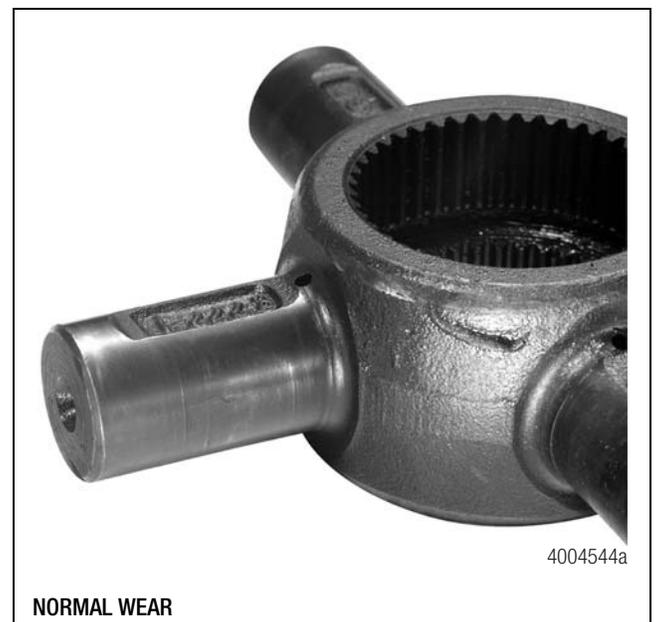
Figure 4.12

Figure 4.12, Figure 4.13, Figure 4.14, Figure 4.15 and Figure 4.16 show how spinout caused a pinion cross to fail. Damage progresses from normal wear, to moderate premature wear, and then to heavy wear; and finally, the pinion cross fails.

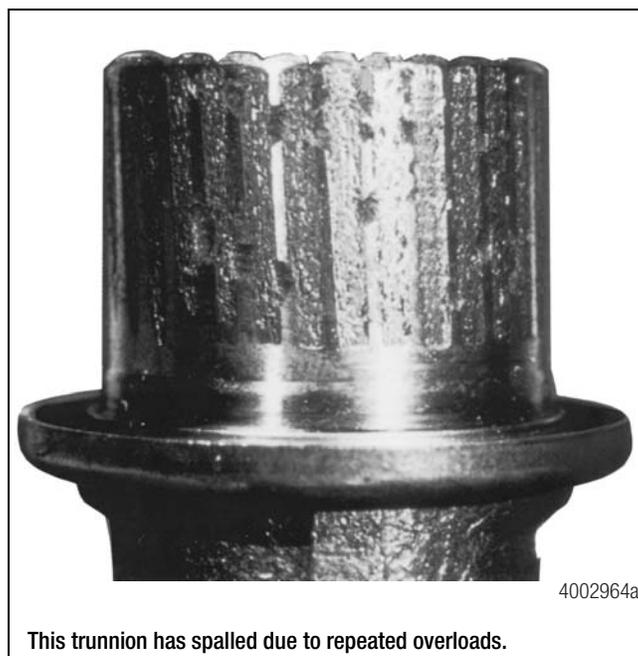
Figure 5.9

This trunnion has spalled due to repeated overloads.

Operate a vehicle within its approved application and weight limits. Follow recommended maintenance practices.

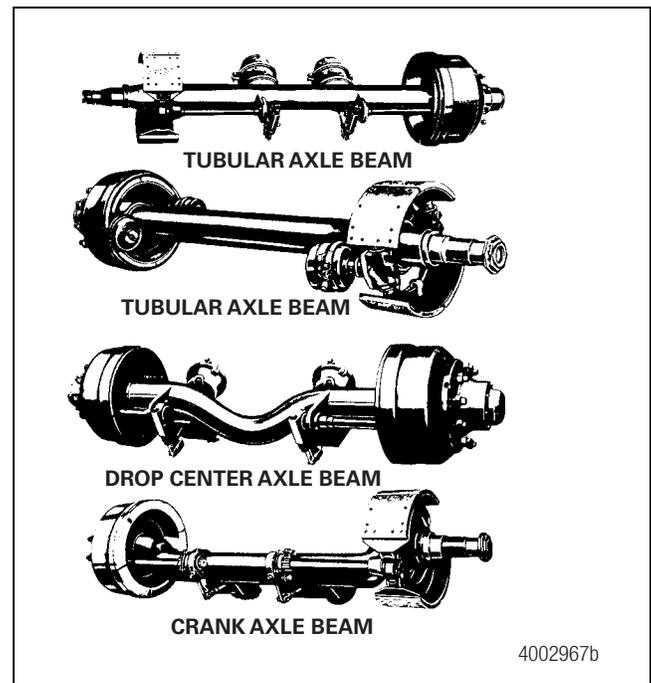
Figure 6.1

Meritor trailer axles are available in a variety of sizes and configurations, and are designed and rated for specific load applications. Figure 6.1. The gross axle weight rating (GAWR) specifies the maximum load limit for a trailer. Trailer axles that are operated above their GAWR can be damaged by torsional fatigue and bending fatigue.

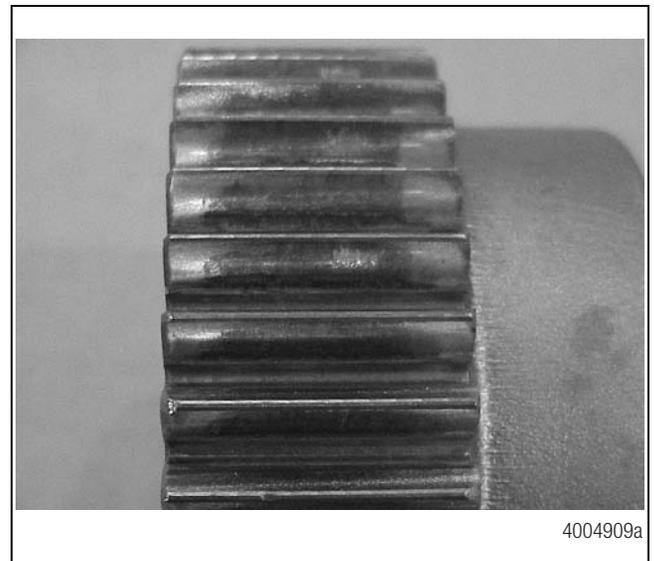
Figure 9.9

No action is required. Frosting is a normal wear condition on spur gear teeth that does not affect performance or gear life. As the gear continues to operate, sliding friction eventually removes frosting. If frosting is the only wear you see on spur gears, do not replace the gears.

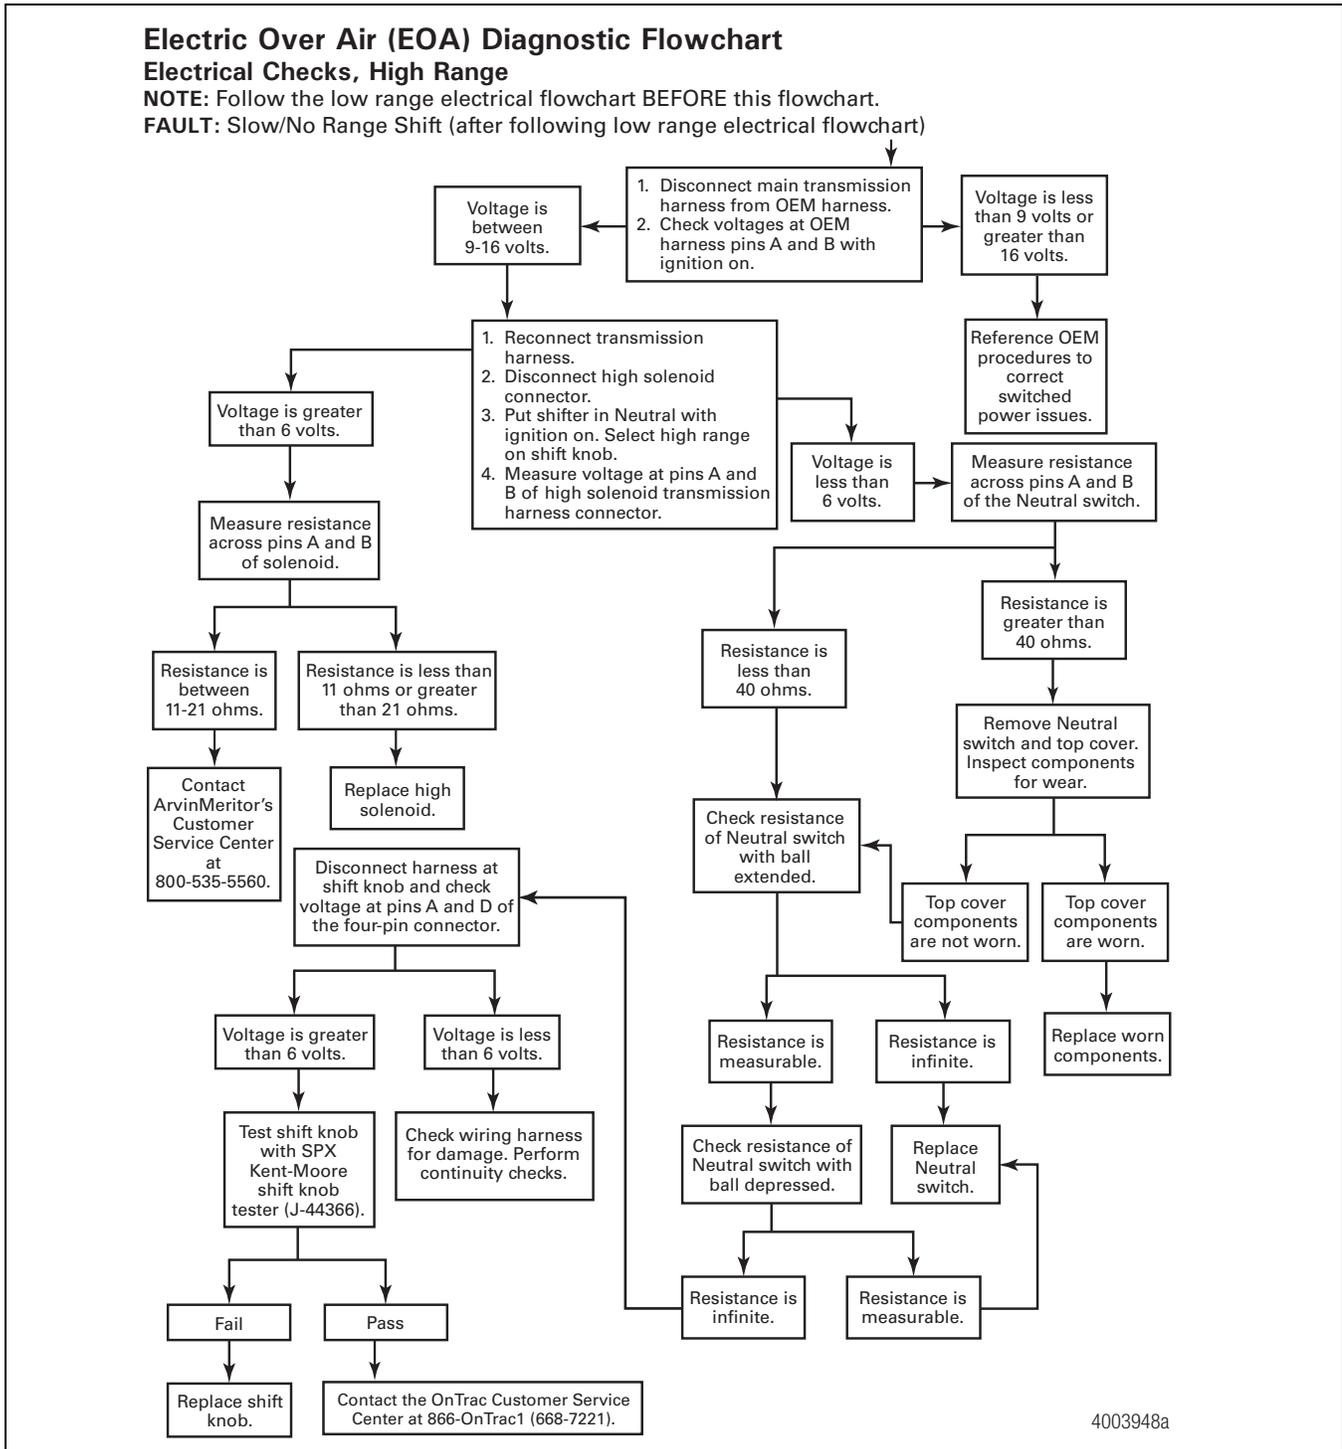
Figure 9.57

3. High Range Electrical Checks — Follow the high range electrical checks flowchart to verify that the high range electrical system functions correctly. Perform high range electrical checks AFTER mechanical checks and low range electrical checks. Figure 9.57.
